Statistical analysis of damages to masonry churches after the 2017 Ischia earthquake

Piera Salzano^a, Francesca Ceroni^a, Claudia Casapulla^b, Andrea Prota^c

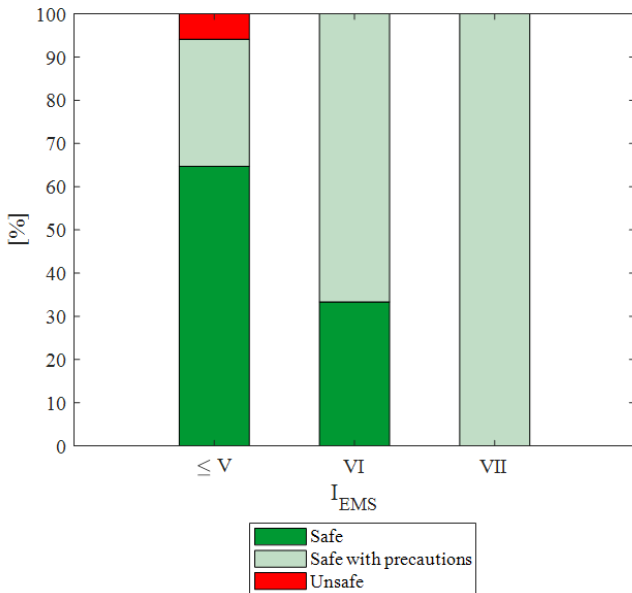
Figure 8. Usability outcomes distribution for 21 one-nave churches.

external cause, unsafe. Figure 8 reports the usability outcomes distribution for the 21 one-nave churches collected according to the assigned macro-seismic intensity. Within such inspections, the 17 churches with a macro-seismic intensity $I_{EMS} \leq V$ were mostly “safe” or “safe with precaution” (94%), while only 1 church located in Forio municipality was “unsafe”. Only three churches attained a macro-seismic intensity $I_{EMS} = VI$ and were “safe” or “safe with precautions”. Finally, only one church located in Casamicciola Terme (San Pasquale Baylon church) was characterized by a higher value of macro-seismic intensity ($I_{EMS} = VII$); nevertheless this church was declared safe with precautions. This result can be due to the overestimation of the macro-seismic intensity for that church, as previously discussed.

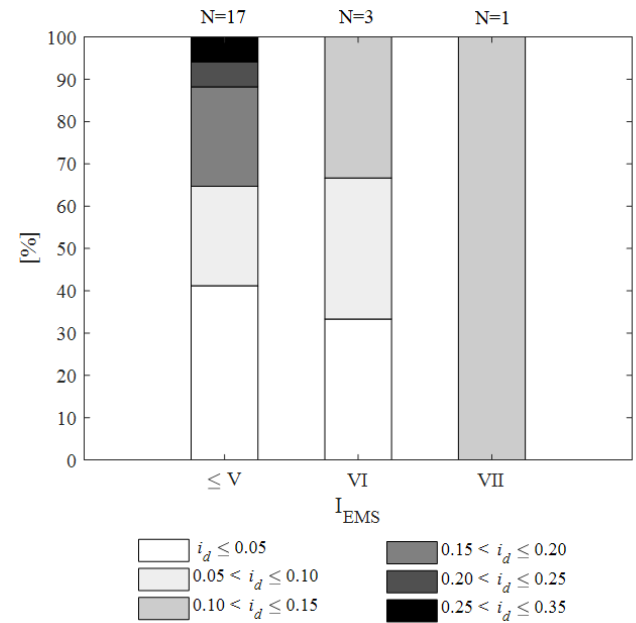
Figure 9. Damage index distribution for 21 one-nave churches.

The values of damage index i_d for the 21 inspected one-nave churches are reported in Figure 9 as a function of the macro-seismic intensity. The assessed damage index varies between 0 and 0.35, that means that the inspected structures suffered an overall slight damage. It is worth noting that the highest damage level was reached for churches with $I_{EMS} \leq V$, as it was also evidenced by the usability checks reported in Figure 8.

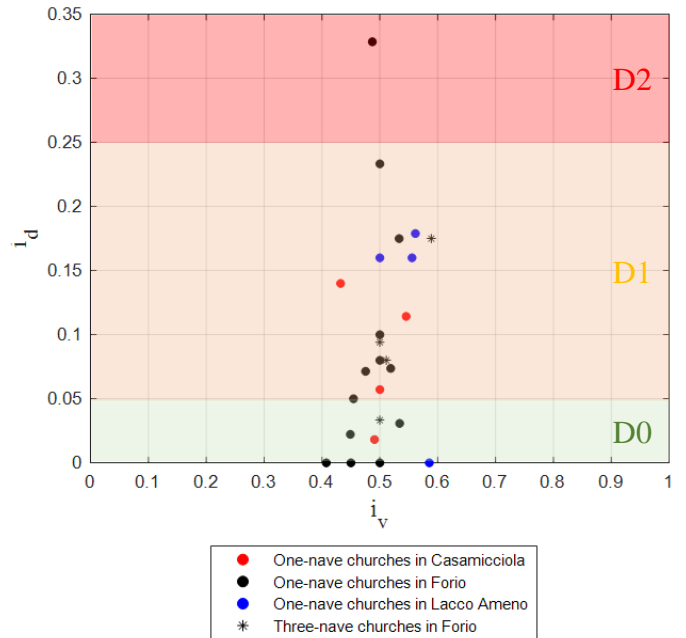
Figure 10. Damage index vs. vulnerability index for 21 one-nave churches and 4 three-nave churches located in different municipalities of Ischia Island.

In order to check if a correlation between vulnerability and damage does exist, the damage index i_d is plotted in Figure 10 as a function of the vulnerability index i_v for both one-nave (21) and three-nave (4) churches, according to the different municipalities to which each church belongs. Moreover, the values of i_d are associated to the EMS damage levels D_k (Grunthal 1998): D0 for $i_d < 0.05$, D1 for $0.05 < i_d < 0.25$, D3 for $0.25 < i_d < 0.40$.

For $i_d > 0.20$ it was not possible to find a clear trend of the damage index with the vulnerability index, also because of the few data available. Nevertheless, for $i_d < 0.20$ an increasing trend of

the damage index with the vulnerability index can be identified, especially for the one-nave churches, even if several inconsistencies are present and discussed in the following.

The two churches with $i_d > 0.2$ are one-nave churches and are located in Forio (San Michele Arcangelo del Purgatorio with 0.33 and Santa Maria di Loreto – Oratorio with 0.23). The first church suffered severe shear damage to the lateral wall and apse (Figure 11b), in addition to the numerous cracks on the vault of the central nave. The latter one also suffered damage to the vault of the central nave (Figure 11c). Nevertheless, in both cases the intrinsic characteristics of the churches did not highlight significant vulnerability sources ($i_v = 0.5$), except for the lack of anti-seismic safety devices.

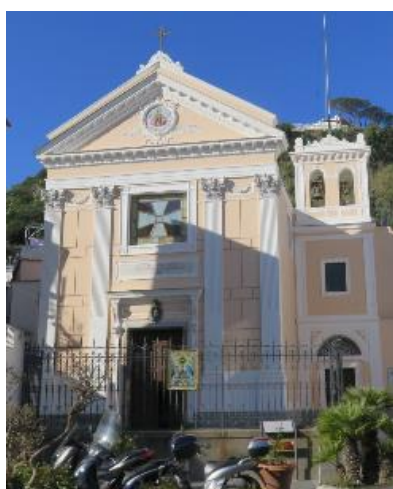
The one-nave churches of Lacco Ameno are characterized by the highest vulnerability (i.e. $i_v=0.551$). As an example, in the Santa Restituta church ($i_v=0.58$), the presence of large openings and a high slenderness have provided significant sources of vulnerability (Figure 11a). However, this church is characterized by a damage index $i_d=0$, that means that the church did not suffer any damage; this outcome is probably related to its distance from the epicentre and the strong attenuation effect that characterized the earthquake (see Section 2.2).

Figure 11. a) Santa Restituta church in Lacco Ameno; b) Shear damage in San Michele Arcangelo church in Forio; c) Cracks on the vault of the central nave of Santa Maria di Loreto - Oratorio church in Forio.
