# Shake-table investigation of a timber retrofit solution for unreinforced masonry cavity-wall buildings

Marco Miglietta<sup>a</sup>, Nicolò Damiani<sup>a</sup>, Luca Grottoli<sup>b</sup>, Gabriele Guerrini<sup>b,c</sup>, Francesco Graziotti<sup>b,c</sup>

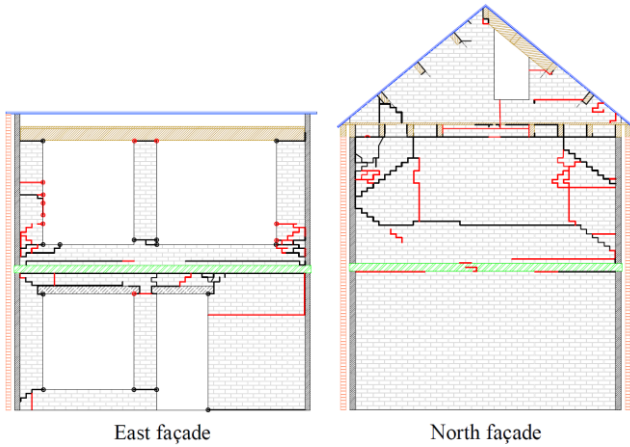
In the bare building, damage was mainly concentrated at the second storey. The lack of connections between masonry and second-floor timber diaphragm allowed sliding to occur, increasing the displacement demand at that storey. Looking at the damage pattern of the East wall presented in Figure 13, it can be seen that the sliding crack between the inner-leaf spreader beam and the masonry was fully developed, denoting a complete loss of the cohesion contribution to the connection capacity. Consequently, the second-storey piers resistance could not be engaged. The transverse walls tended to displace out of plane, following the second-floor diaphragm, and involved the slender return walls of the longitudinal facades. The North transverse wall tended to detach from the second storey squat pier with a vertical crack forming along the North-West corner. The significant difference in displacement demand that occurred between first and second storey can be clearly seen on the North-side inner leaf (Figure 13): widespread damage accumulated at the second storey while the first one was almost intact. The same conclusion can be made by looking the crack pattern evidenced on the North clay façade (Figure 14).

Figure 13. Bare building crack pattern after EQ-NPR-100%: CS inner leaves.

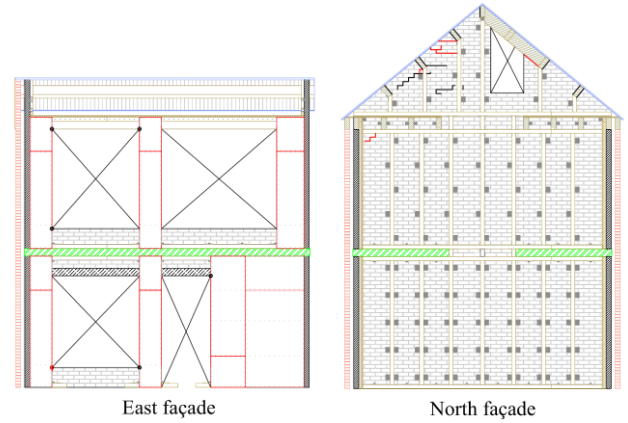
Focusing on the retrofitted building (Figure 15 and Figure 16), the accumulated damage was significantly lower. Only hairline cracks were detected on the inner leaves (Figure 15): at the roof-gable system, which was demonstrated to be

Figure 15. Retrofitted building crack pattern after EQ-NPR-100%: CS inner leaves transverse walls.

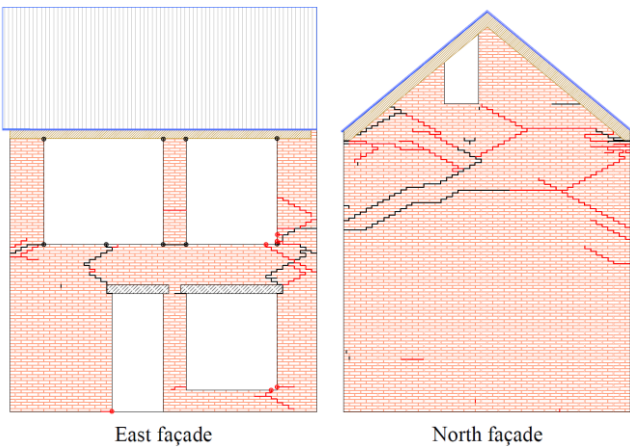
Figure 14. Bare building crack pattern after EQ-NPR-100%: clay external veneers.

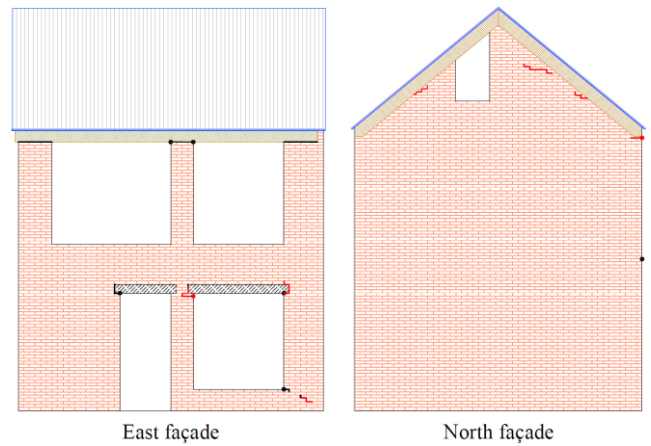
Figure 16. Retrofitted building crack pattern after EQ-NPR-100%: clay external veneers.

particularly flexible in this typology of buildings (Graziotti et al 2017); and on the South side, due to the interaction between second-floor timber beams and the supporting CS wall. Also the clay outer leaves presented minor damage (Figure 16), hairline cracks were detected at the interfaces between spreader beams and masonry, between lintels and masonry, and between roof purlins and masonry.

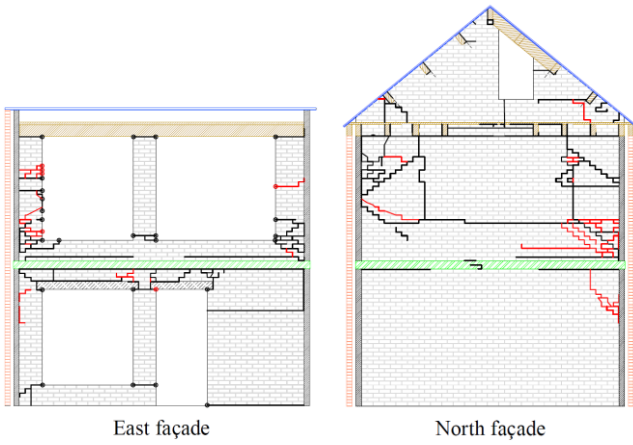
The last test run for the bare building was performed under EQ-NPR-133%-R (PGA = 0.4g). The specimen showed heavy damage at the second storey, while limited damage developed at the first one on both inner and outer leaves (Figure 17 and Figure 18). No new mechanisms were activated and the distribution of cracks was very similar to the one observed after EQ-NPR-100%. However, residual crack widths increased significantly (up to 50 mm) and the structure at the end of the test was very close to loose static stability. Figure 19 shows the accumulated crack width between the second storey squat-pier (West side) and the transverse wall (North side). Figure 20 depicts the developed

Figure 17. Bare building crack pattern at ultimate conditions: CS inner leaves.

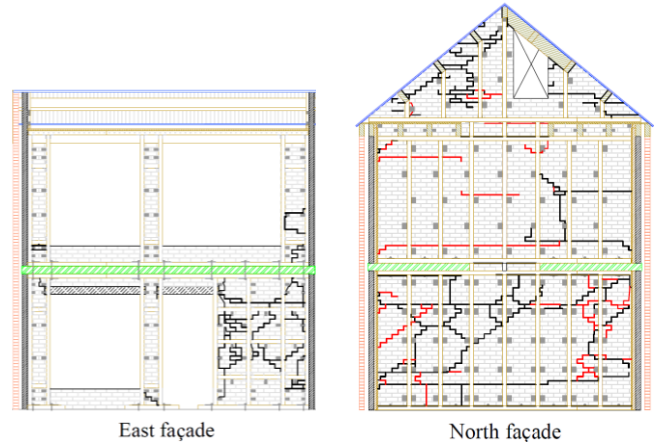
A completely different ultimate state was reached by the retrofitted building (Figure 21 through Figure 23), which was able to sustain the applied ground motion up to EQ-NPR-266% (PGA = 0.8g). The timber retrofit system allowed a full exploitation of the masonry capacity due to the enhancement of connections and of the in-plane and out-of-plane resistances of the walls. Remarkably, the adopted strengthening measures led the building to develop a torsional response that allowed to take advantage of the in-plane resistance of the first-storey transverse walls.

As opposed to the bare building, the CS inner leaves were heavily damaged at the first storey, with significant residual crack widths (up to 35 mm), while the second storey showed diffuse damage yet with only hairline cracks (Figure 21 and Figure 23). Looking at the clay veneer of the North façade, widespread damage could be observed throughout the whole height (Figure 22) rather than concentrated at the second storey.

Figure 21. Retrofitted building crack pattern at ultimate conditions: CS inner leaves.

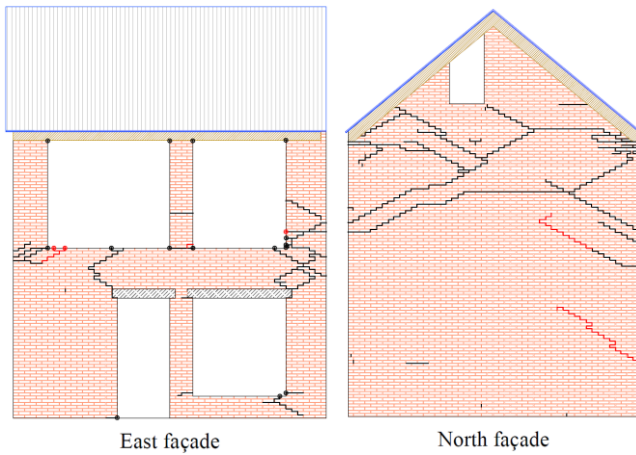
Figure 18. Bare building at ultimate conditions: longitudinal clay outer leaves.

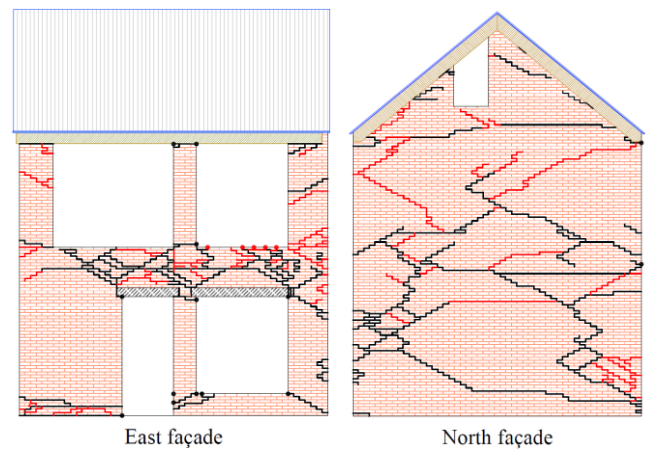
Figure 22. Retrofitted building crack pattern at ultimate conditions: clay outer leaves.

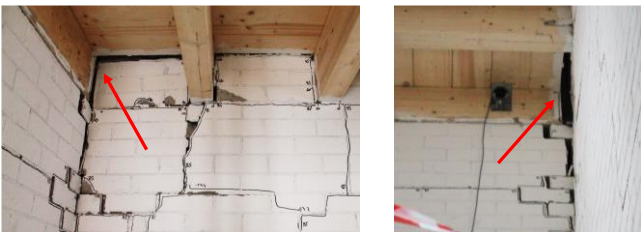
Figure 19. Bare building at ultimate conditions: second storey North-West corner.

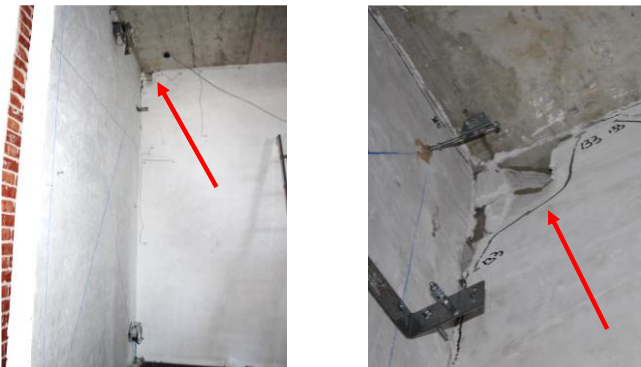
damage of the first storey squat wall of the East façade at the corner with the South transverse wall.

Figure 20. Bare building at ultimate conditions: first storey South-East corner.

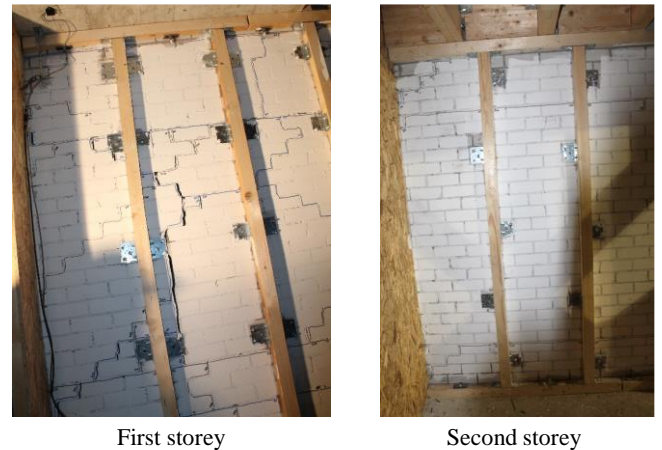
Figure 23. Retrofitted building at ultimate conditions: transverse walls.
