Seismic vulnerability of churches: the effect of context-related characteristics

Keywords: masonry churches; seismic vulnerability assessment; damage mechanisms, Québec

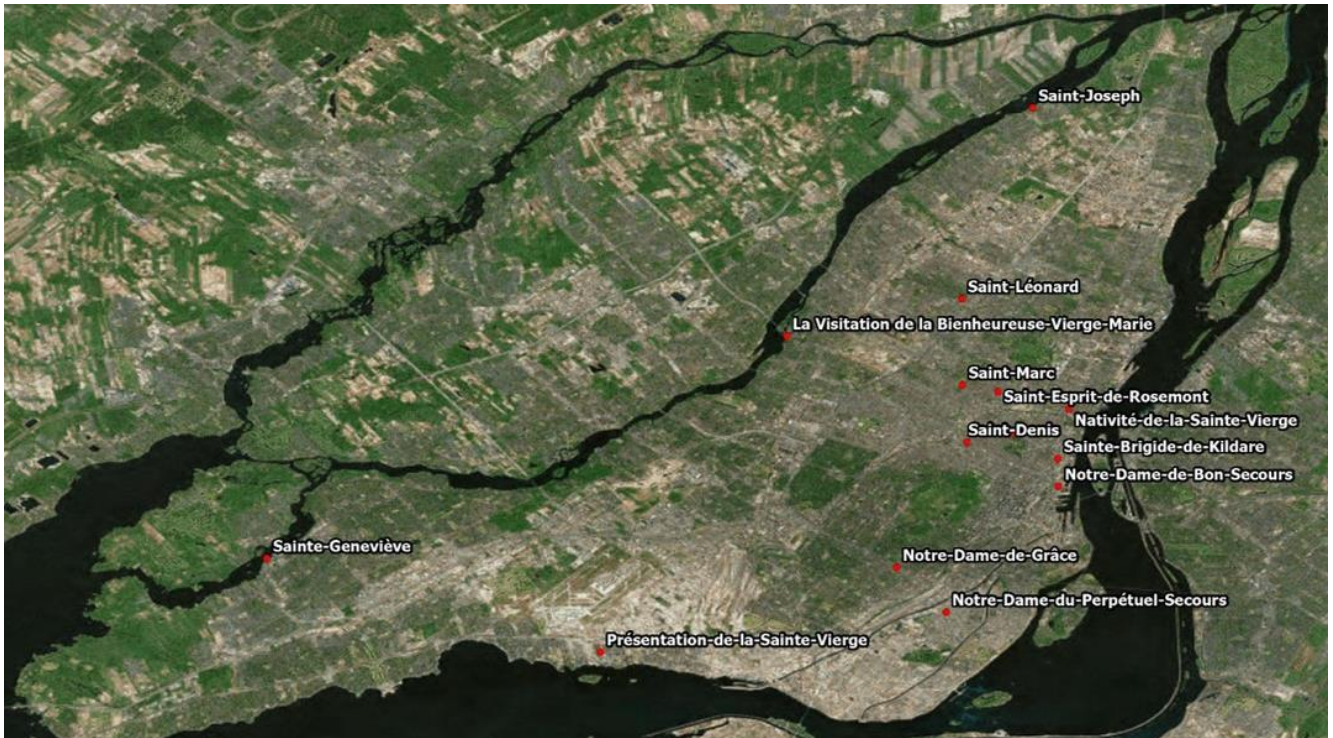
Figure 2 indicates the set of churches further investigated. Each church has been inspected, with the aim at pointing out the local construction characteristics that were expected to affect the seismic structural behaviour. Based on the Italian experience, the presence of elements inducing vulnerability for these structures was checked. The sample was composed of several church typologies. This aspect has pointed out the necessity of observing more specifically the vulnerability for each of them. In fact, working by categories has allowed to observe more in detail the territorial specificities (Sferrazza Papa et al. 2019).

Figure 2. The Seismic hazard map of Québec from the Canadian Building Code (CNBC 2015).

Among the identified church typologies, a first deeper study is in progress on the néo-roman typology. Saint Joseph, one of the visited churches (Figure 2), was chosen as a case study. A detailed geometrical survey was performed onsite, and a 3-D model of the entire church was elaborated to understand the relation between the different structural elements, due to the structural complexity. This stage was fundamental for the next stage, the elaboration of the global numerical model. To understand the implication of such a mixed structure, timber and masonry, and the global structural behaviour, a first model with just the masonry part was done. As first stage, the contribution of the timber roof and the bell tower was considered as applied masses. **Errore. L'origine riferimento non è stata trovata.** summarizes the first results of the modal analysis of the entire church. They will be compared with those from the modal analysis that is going to be performed including the timber structure of the roof and the bell tower.

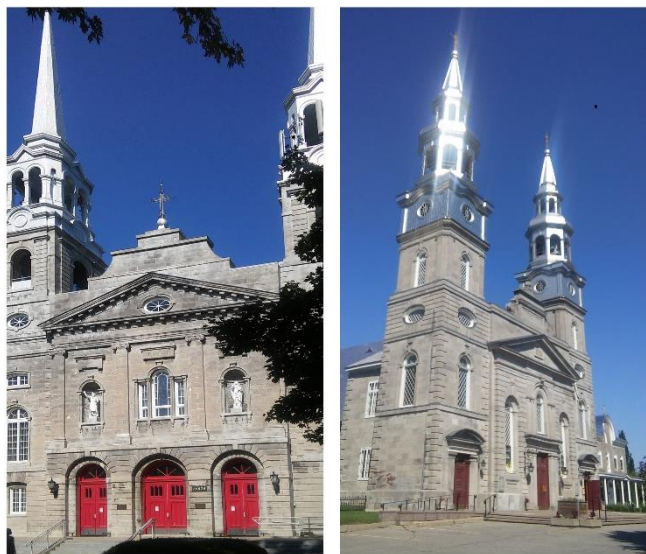
Figure 4. Baillargé typology: two examples of churches.

The *Baillargé typology* has a façade enclosed by two bell towers (Figure 4). The façade has a symmetrical layout. At the ground floor, it generally presents a principal entrance door in the middle of the façade, and openings or niches on both sides of the entrance. At the second order of the façade, a large central opening, on top of the entrance, and other openings or niches, organized symmetrically, characterize the front. In this typology, the façade and the two bell towers create a sort of diaphragm that separates the exterior from

the interior of the nave with an atrium, constituting a massive structure annexed to the rest of the structure of the church. The bell towers are made of masonry up to the first level of the belfry that is higher than the cornice of the gable, while the rest of the structure, that continues above, is made of timber, sometimes painted and other times covered with laminates. The Baillargé churches have typically three naves.

In this case, the façade is not directly connected with the longitudinal walls of the nave, but it is attached to the two bell towers. Moreover, the façade and the bell towers, for their configurations, constitute a diaphragm,

structurally located before the beginning of the colonnade of the nave and the rest of the church structure. A global numerical model could facilitate the comprehension of the influence of such a massive structure directly connected with the nave. The position of the gable, incorporated between the two bell towers, as the rest of the façade, is also interesting to be studied, recurring to local numerical modelling to provide an interpretation of the mechanism on the overturning of the gable. Another characterising aspect for these types of churches is the mixed use of masonry and timber for the structure of the bell tower: the first is used up to a level above the façade, while the second is employed in the higher portion. The transversal response of the nave as well as the longitudinal one of the colonnades require a deeper study. Indeed, the mixed use of timber and masonry makes the structural interpretations difficult for these aspects. The in-plane mechanisms from the listed 28 ones, which describe possible shear cracks in the walls, are valid here, due to the similarities with the Italian churches for the masonry box structure.

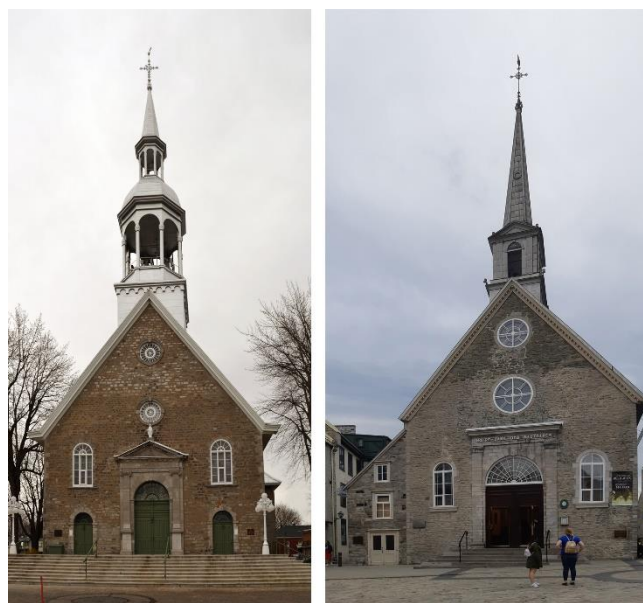
Figure 5. Conefroy typology: two examples of churches.

The *Conefroy typology* is characterized by a bell tower located in the middle of the façade, set back from the façade plan (Figure 5). The façade is frequently characterized by a symmetrical shape in axis with the bell tower and the entrance door, which gives directly access to the nave of the church. Two rose windows, one under the other, are aligned along the axis of symmetry of the façade. One such opening is close to the cornice, at the level of the roof, and one gives light to the nave. Moreover, two large windows are located in the left and right portion of the façade. In some cases, two doors are also present, aligned with the windows, to provide additional access to the church. The pillars of the bell tower are well visible inside the church at the beginning of the nave. Four pillars support the entire structure of the bell tower. They generally describe a square shape, corresponding to the upper part of the bell tower, and they constitute a distinguishing element in this church typology. In the interior of the church, the pillars are arranged in two pairs, one pair is close to the façade and the other penetrates the jubé level, the inner tribune over the main entrance,

ending at the ground level of the church. Conefroy churches have a single nave.

The particularity of this typology is the position of the bell tower and the way it is built in relation with the rest of the church structure. The columns of the bell towers do not interact with the façade structure, just at the roof level, the beams enter the façade wall. The kinematic chain mechanisms, associated to the façade and the bell tower, have to be reconsidered in the light of these specific characteristics. The rest of the structure can be easily read recurring to the rest of the listed mechanisms. The interlocking between the walls that constitute the masonry box of this type of church is generally well-defined with square stone blocks. Some identified cracks that, in case of earthquakes, can facilitate the activation of some mechanisms, were observed. In particular, they were found in correspondence of the central rose window and symmetrically in the façade plane in proximity of the openings. To interpret the implication of the bell tower in such a position, a deeper study on Conefroy churches is in progress.

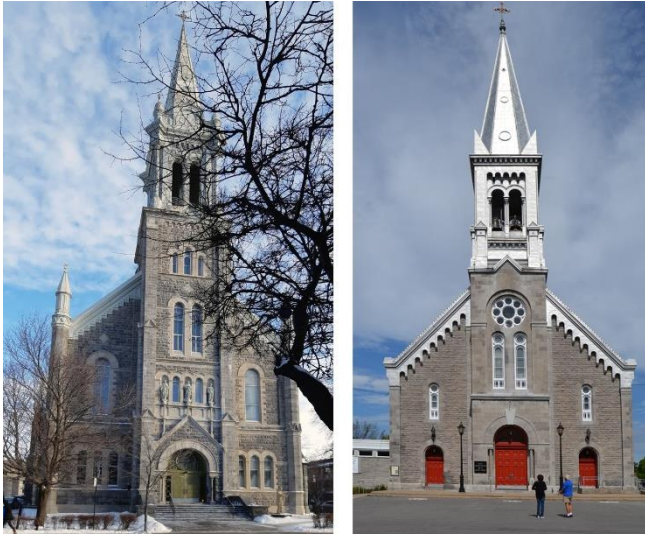
Figure 6. Néo-Roman typology: two examples of churches.

The *néo-Roman typology* is characterized by the position of the bell tower that, occupying the central position, interrupts the continuity of the façade and provides the distinguishing configuration visible in Figure 6. The detailed inspection of this typology was fundamental for the comprehension of the structural system that involves the façade and the bell tower. Visiting also the roof and bell tower, the mixed use between timber and masonry was observed. This complex structural configuration makes this typology particularly interesting and worth being more deeply investigated. Néo-Roman churches have typically three naves.

In this case, the position of the bell tower, that interrupts the façade plan, and the mixed use of timber and masonry do not make it possible to interpret directly the structural behaviour according to the identified mechanisms usually associated to the macro-elements “façade” and

“bell tower”. This church typology is under investigation: some numerical models are being developed to understand the implications of such a mixed structure and to set up criteria for the seismic vulnerability assessment (Sferrazza Papa et al. 2019). Also in this case, some cracks were identified. In particular, some symmetrical cracks were observed in the longitudinal walls of the nave in proximity of the façade and in the façade plane in correspondence of the large windows at the second order.

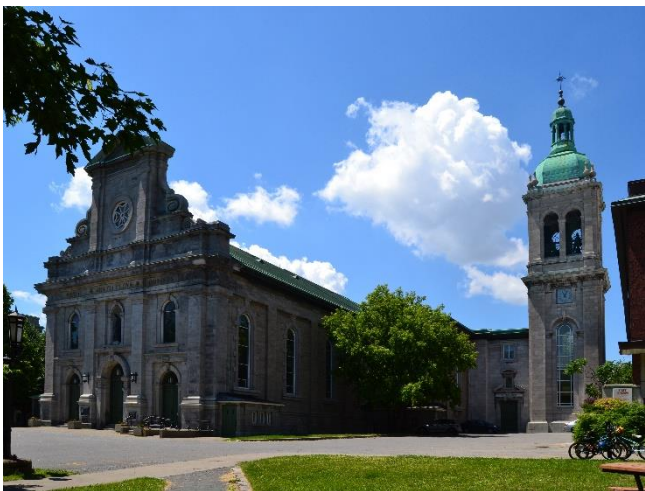
Figure 7. Example of an Italian baroque typology.

The *Italian baroque typology* is characterized by the high slender and lofty façade with pilasters. These regulate the design of the façade and the volutes embellish the gable at each side.

This church typology is composed of three naves that repeat the exterior rhythm of the façade. Most churches of this building typology have

unfortunately been destroyed. Figure 7 shows one example of Italian baroque church. In consequence of some renovation works, the interior was transformed from the original state, keeping the three nave distribution, but replacing the vault and arch system, typical of a baroque church, with a flat non-structural slab. Consequently, the structural concept was deeply modified.

This was the typology most similar to the Italian cases. The lofty façade without any seismic devices presents a high vulnerability. At the same time, for the examined case the interior changes, from a vault and arch system to a flat slab, have modified the structural response of the church structure to lateral forces. Although the churches corresponding to this typology are only a few left, it is a clear example of how modifications not related to structural needs can alter the structural conception of a historical building.
