Seismic vulnerability of churches. First results of the study on three façade typologies

Vito Tateo^a, Gessica Sferrazza Papa^a

^aDepartment of Architecture, Built Environment and Construction Engineering, Politecnico di Milano, Piazza Leonardo da Vinci 32, 20133 Milano, Italy

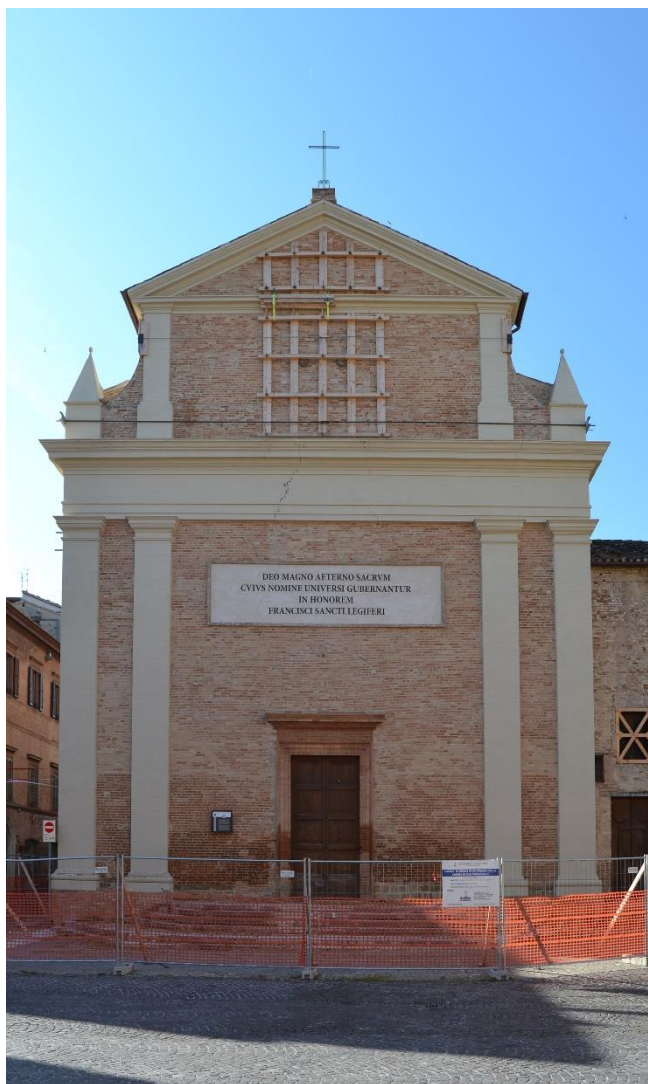
Figure 3. The façade of San Francesco in Tolentino (MC).

The church of San Francesco is located in Tolentino (MC). This church has a rectangular and regular plan. It has niches on both sides of the nave and massive buttresses in correspondence of the arches, giving rhythm to the nave. One of the buttresses, per each side of the nave, is built against the façade, increasing the stiffness of this macro-element. The church was built in XIII century, with the last transformations in the XVIII century, related to the vault system of the nave. The façade of this church clearly shows the brick texture, relegating the plaster to the pilasters and the cornices (Figure 3). The masonry wall of the façade is made of thin bricks with a dimension of 24x4 cm. The thickness of the façade wall is about 95 cm and, in absence of non-destructive tests (NDT), it was considered for the aim of this study as a single leaf wall. This hypothesis was elaborated in consequence of some damage

The damage form for this church, filled after the 2016 Central Italy earthquake, reports the following levels of damage according to EMS-98 (Grunthal et al. 1998): 2 (moderate damage) for the overturning of the façade and 3 (severe damage) for the gable mechanism.

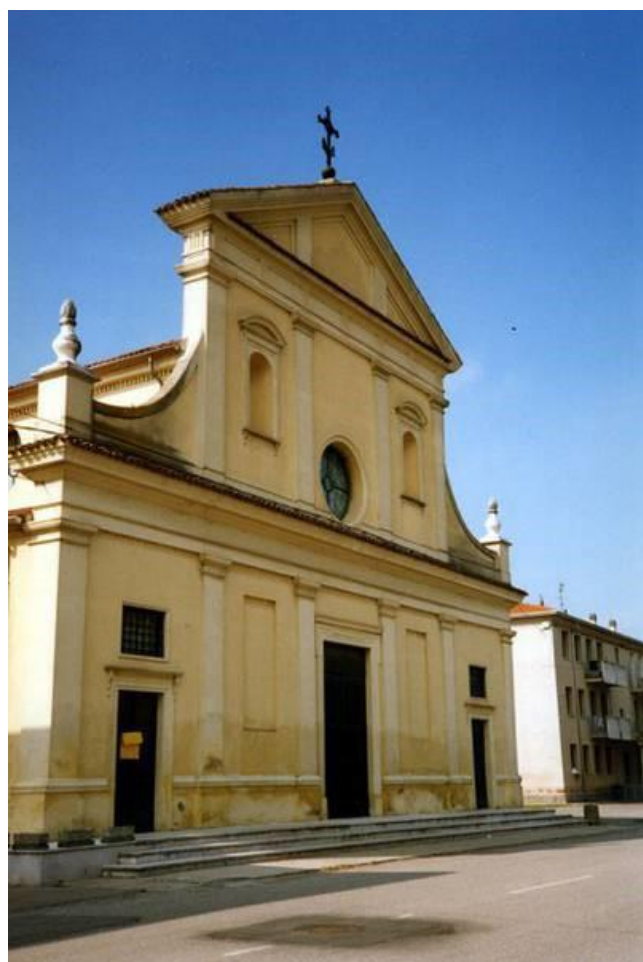
Figure 4. The façade of San Giovanni Battista in San Giovanni del Dosso (MN).

The church of San Giovanni Battista in San Giovanni del Dosso (MN) is an example of baroque church. Other churches of this style were found among the damaged churches after the 2012 Pianura Padana earthquake. The church was built in the 1616 and it is a three nave church. The façade is characterized by a central principal entrance in axis with the rose window and two secondary doors symmetrically disposed per each side and corresponding to the lateral naves. Moreover, one cornice separates the first from the second order of the openings, and another distinguishes the second order from the lofty gable. An arch, built against the façade, is the last element of a repetitive structure of arches and

vaults that covers the central nave. The façade has a rhythm associated with the pilasters (Figure 4). The masonry wall of the façade is made of thin bricks organized with a regular pattern that were visible from photos taken inside the church at the roof level. Also in this case, in absence of non-destructive tests (NDT), the masonry section was considered constituted of just one single leaf.

The damage form for this church, filled after the 2012 Pianura Padana earthquake, reports the following levels of damage: 4 (extremely severe damage) for overturning of the façade and 5 (collapse) for the gable mechanism.

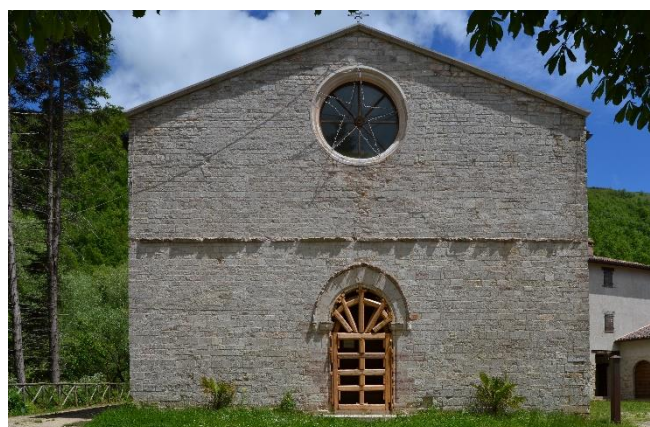
Figure 5. The façade of San Salvatore in Acquapagana (MC)

The church of San Salvatore in Acquapagana (MC) is an example of the medieval typology, diffused in Central Italy. The church was built in XI century, it has a single and symmetric nave with the entrance in axis with the square apse. The roof is a light timber one. The façade reflects the simplicity of the church with a hut shape and a simple white stone portal (Figure 5). The masonry wall of the façade consists of three leaves with some cross-stone blocks. The external leaves are made of square stones, joined by thin layers of mortar, arranged to form a regular pattern (Sferrazza Papa and Silva 2018). The façade is 90 cm thick, while the lateral walls are 83 cm.

The damage form for this church, filled after the 2016 Central Italy earthquake, reports the following levels of damage: 2 (moderate damage) for the overturning of the façade and 3 (severe damage) for the gable mechanism.

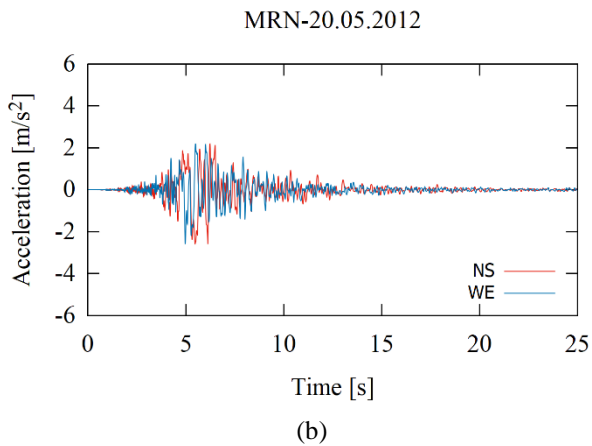
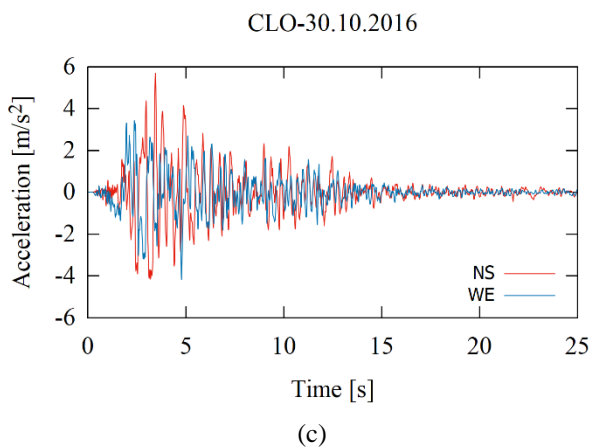
The North-South (NS) and East-West (EW) components of the considered accelerograms are reported in Figure 6. For all the ground motions, the NS component has higher values of acceleration than the EW. For this reason, the NS accelerogram was applied to the façade and the EW to the lateral walls. In Figure 6, the elastic response spectra of the recorded accelerograms are compared with the response spectra of the church sites according to the Italian Building Code (NTC 2018).

Figure 6. The accelerograms used for the dynamic non-linear analyses registered in (a) Novi di Modena, (b) Mirandola and (c) Castelluccio di Norcia.

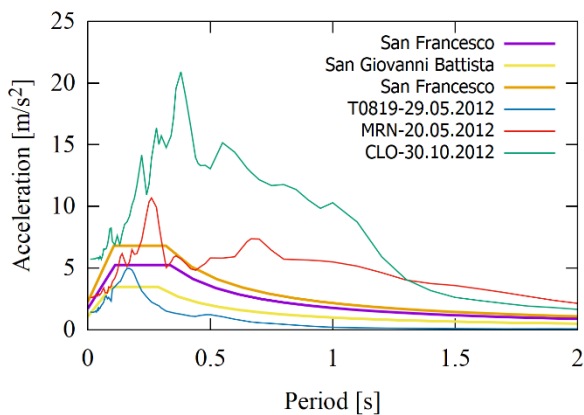
Figure 7 shows that the CLO-30.10.2012 spectral accelerations are higher than the ones defined by the code in the three church sites for the Ultimate Limit State (SLU). Furthermore, comparing the three response spectra for the three churches, the different seismic hazard for the three sites can be evaluated.

Figure 7. The elastic response spectra of the NS component of the considered accelerograms. The purple, yellow and orange lines are the response spectra reported by the Italian building code for ultimate limit state in the three church sites.

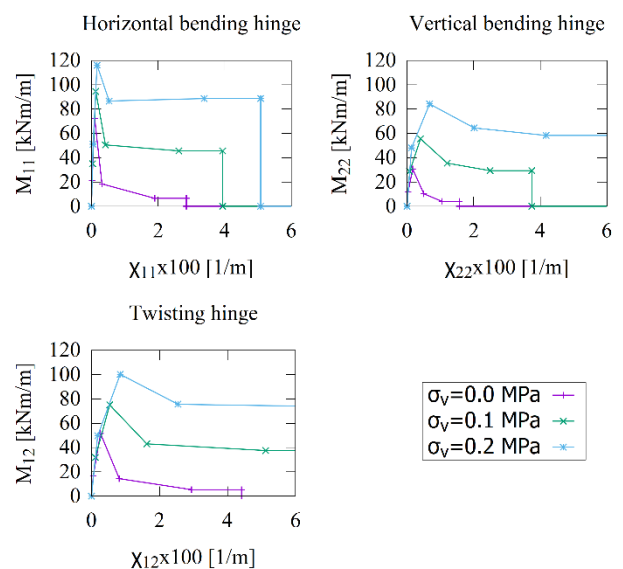
For the material properties, the values for “masonry with solid bricks and mortar”, reported in the Italian Building Code (Circolare n° 7 del 21 Gennaio 2019), were adopted. For the horizontal bending behaviour, the friction coefficient was assumed equal to 0.4 and, considering the bricks geometry (24x4 cm), a shape coefficient equal to 3 was assumed. Figure 9 reports the obtained moment-curvature relationships for different levels of vertical compression.

Figure 9. Façade of San Francesco. Piecewise moment-curvature relationships of the bending and twisting rotational springs, for different levels of vertical compression stress σ_v . The points are called, for increasing value of the curvature, E, Y, U, S and Crack point.

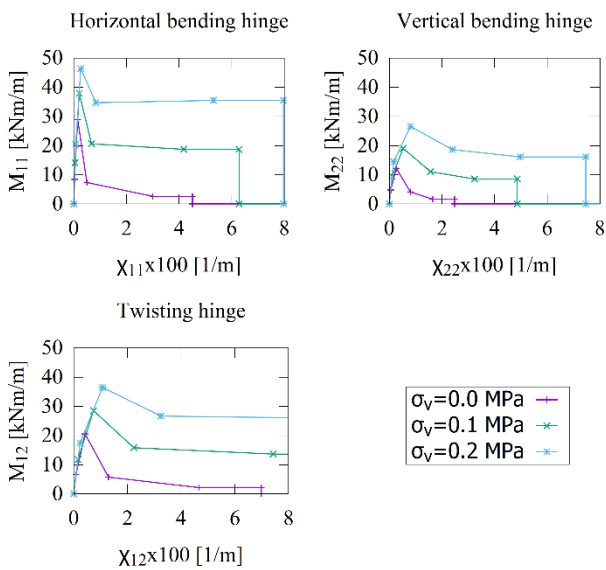
For the materials, the same values of San Francesco were adopted. However, in this case, the shape coefficient ρ was assumed equal to 2, considering that in average the bricks are 24x6 cm. Figure 11 reports the obtained moment-curvature relationships for different levels of vertical compression.

Figure 11. Façade of San Giovanni Battista. Piecewise moment-curvature relationships of the bending and twisting rotational springs, for different levels of vertical compression stress σ_v . The points are called, for increasing value of the curvature, E, Y, U, S and Crack point.

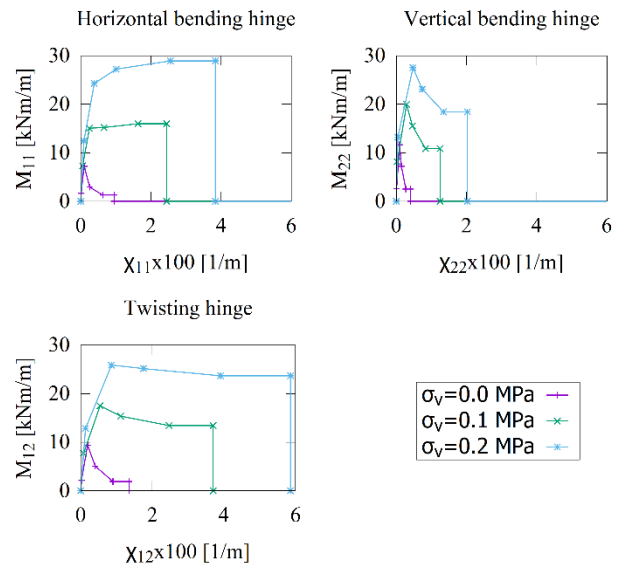
The façade of San Salvatore has an average thickness of 90 cm. It was assumed that the external leaves, made by square stones, are 20 cm thick, with an inner core of poor mechanical properties of 50 cm. The material parameters of the external leaves were assumed in agreement with the values for “masonry with square stone blocks”, reported in the Italian Building Code (Circolare n° 7 del 21 Gennaio 2019). Figure 13 shows the obtained moment-curvature relationships for different levels of vertical compression.

Figure 13. Façade of San Salvatore. Piecewise moment-curvature relationships of the bending and twisting rotational springs, for different levels of vertical compression stress σ_v . The points are called, for increasing value of the curvature, E, Y, U, S and Crack point.

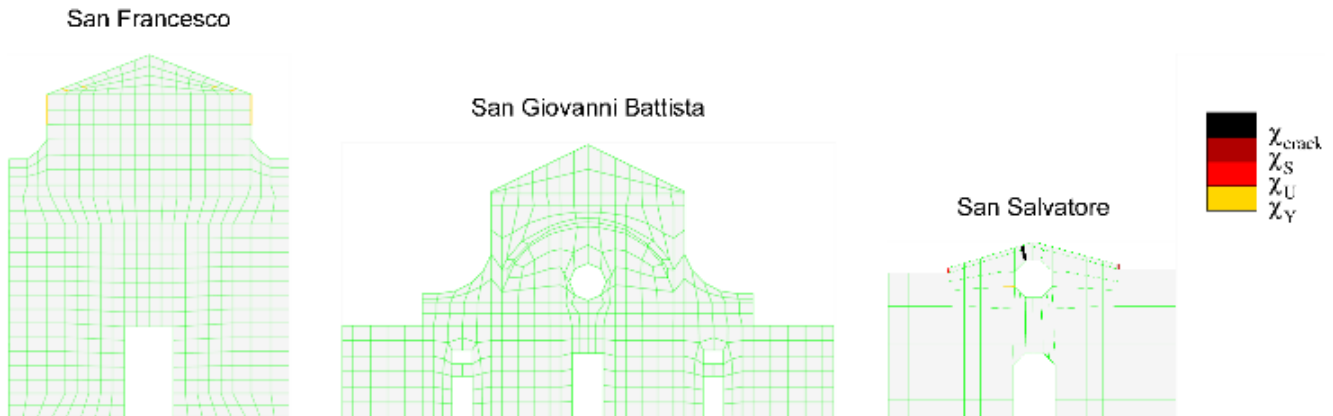
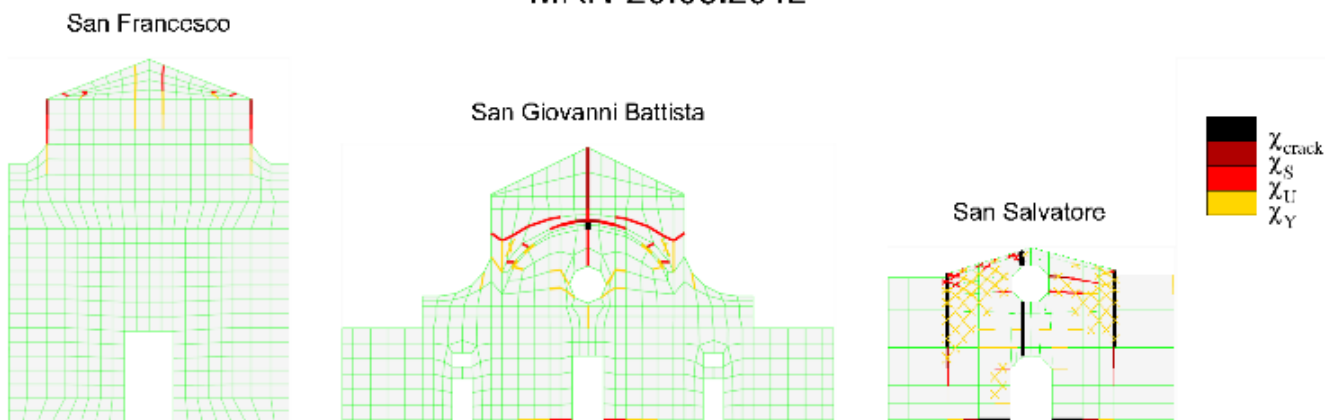
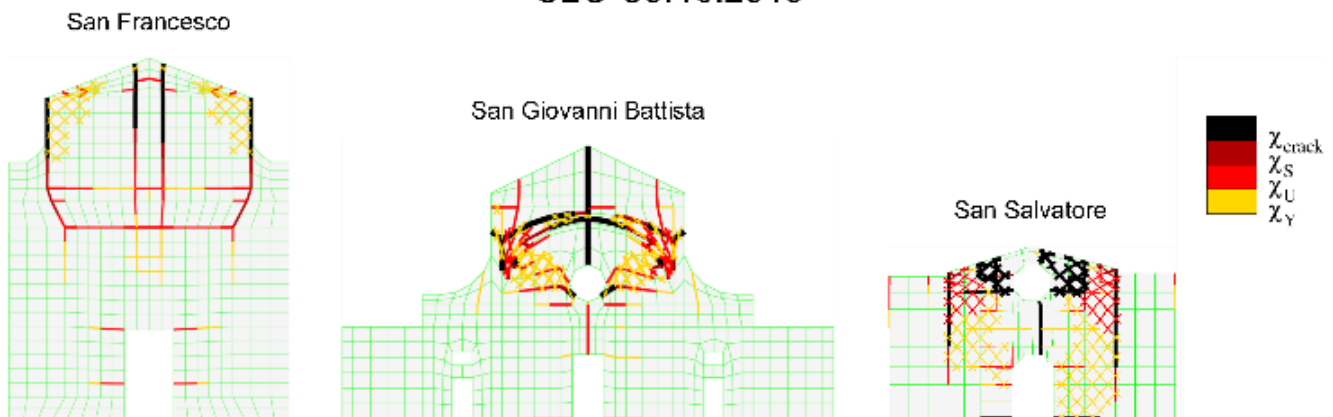
Figure 14. Damage patterns obtained for the three façades applying the three accelerograms with increasing values of the PGA: T0819-29.05.2012 (PGA=0.15g), MRN-20.05.2012 (PGA=0.26g), CLO-30.10.2016 (PGA=0.58g).

patterns. The damage state is plotted in terms of maximum average curvatures reached in the connections. If the maximum bending curvature is higher than the Y-point curvature a straight coloured line is plotted along the side. On the contrary, if the twisting curvature exceeds the Y-point curvature, a coloured cross is plotted in the connection point.

The damage maps (Figure 14) show that for the two strong motions with the highest values of PGA

(MRN-20.05.2012 and CLO-30.10.2016) the façade of San Salvatore is the most damaged with several springs that reach the crack curvature value. The damage is concentrated around the rose window and at the intersection with the lateral walls. A prevalent mechanism of façade overturning was observed for the Mirandola accelerogram. Whereas, for the Castelluccio di Norcia accelerogram (PGA=0.58g), the

overturning of the gable, over the rose window, was also observed.

For the same two accelerograms, the façade of San Giovanni Battista results widely damaged. In this case, the damage is more severe above the arc, with the formation of an almost horizontal yield line and the consequent overturning of the tympanum. This damage is the same that occurred during the 2012 Pianura Padana earthquake. Furthermore, a vertical hinge cuts the middle of the façade getting to the rose window.

The façade of San Francesco is the least damaged by these two events. For the same two accelerograms, the damage is concentrated in the second order of the façade with the formation of vertical hinges at the intersection with the lateral walls and in the centre of the façade, as in a mechanism of overturning of the gable.

For the Novi di Modena accelerogram (T0819-29.05.2012), that has spectral accelerations lower than those reported in the Code, all the façades are almost undamaged. The only exception is represented by San Salvatore where a vertical hinge above the rose window is severely over the elastic limit. Only in this case, the façade of San Francesco is more damaged than the one of San Giovanni Battista, two vertical hinges are already activated at the intersection with lateral walls of the second order.

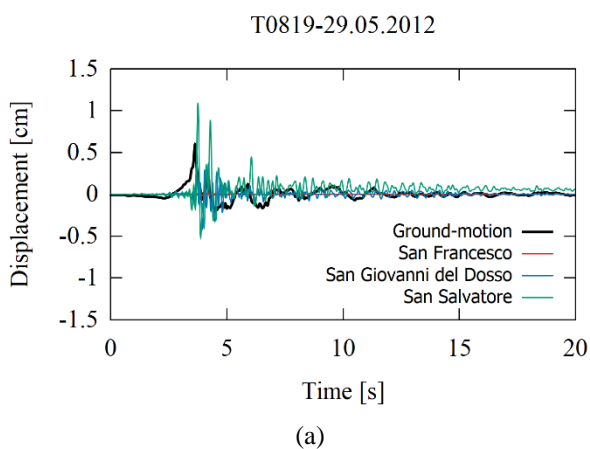
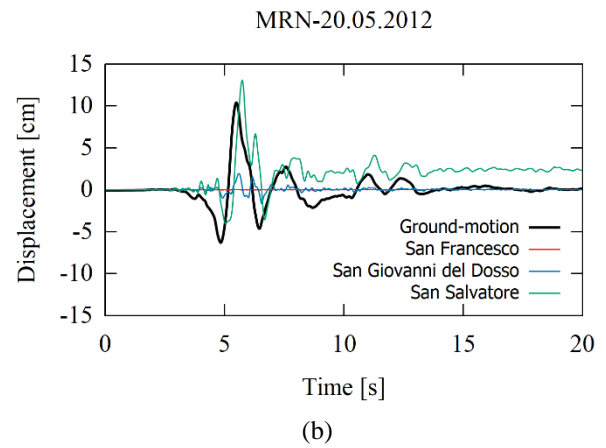
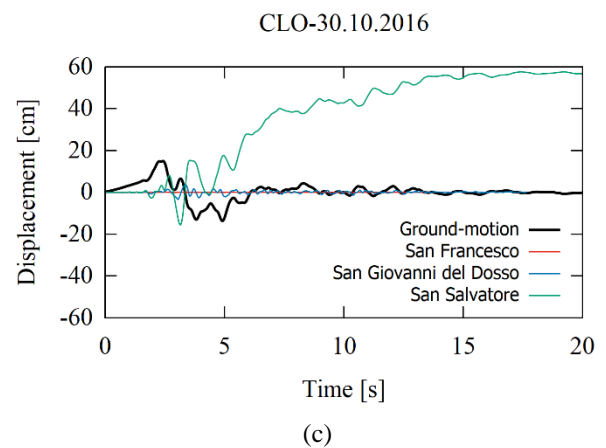
The different seismic response is also confirmed by the history of displacement of the highest point of the façade, selected as control point (Figure 15). The San Salvatore façade is the only one that shows considerable increasing residual displacements for the three seismic solicitations. On the contrary, the stiff San Francesco façade shows very little displacements, independently from the seismic solicitations.

Figure 15. History of displacement of the highest point of the façades for the different seismic events: (a) Novi di Modena, (b) Mirandola and (c) Castelluccio di Norcia.
