## Experimental response of historic brickwork

*Keywords: Historic brickwork masonry; experimental tests; failure mechanisms; FEM.*

### ABSTRACT

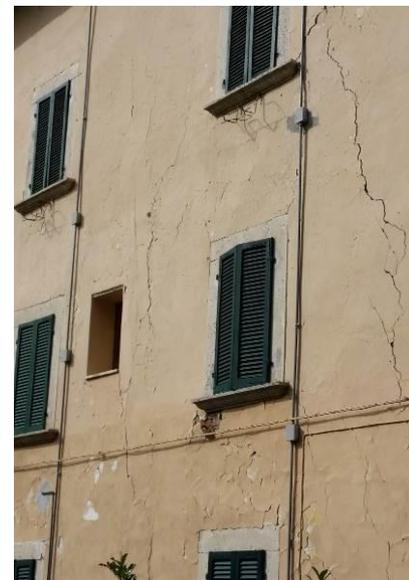
Figure 1. Cracking in historic building after earthquake: Pescara del Tronto, Italy.

particular, the compressive behaviour of historic brickwork subjected to loading, as often recorded during seismic events in Italy, influenced historic brickwork buildings' loss of resistance as tensile failure of bricks. (Fig. 1).

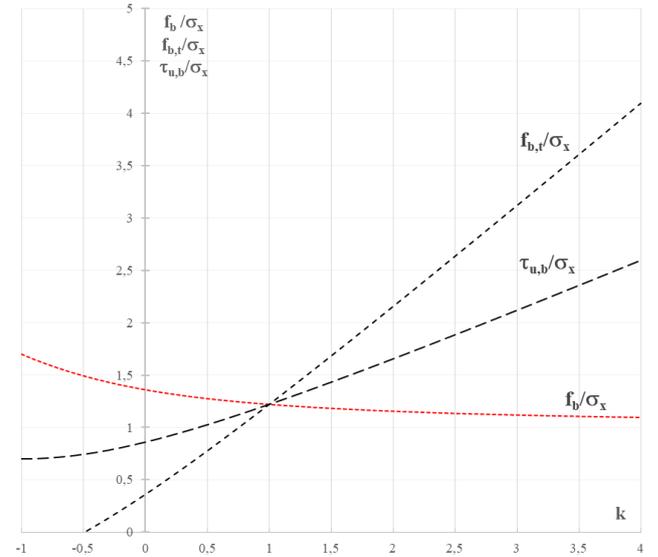
In Fig. 2 adimensional diagrams of the failure mechanisms for masonry are shown having introduced tensile and compressive strength for brick:  $f_{bt}$ ,  $f_b$ . The coefficient of friction between brick and mortar in the case of historic masonry may be equal to  $0.70 \div 0.74$  (Capozucca 2011, 2017) so that, if the mechanical parameters shown in Eq. (5) are known by experimental tests, the main failure mechanisms of masonry under compression can be evaluated by adimensional diagrams of Figure 2.

Figure 2. Adimensional diagrams of the failure mechanisms for masonry.

Experimental results on historic brick wallettes allow us to discuss failure mechanisms. Fig. 2 contains dimensionless diagrams relative to the three mechanisms theoretically foreseen by Eqs. (8), (9) and (10) for the value of coefficient  $k$ ; coefficient  $k$  can be evaluated from the aforementioned experimental data to determine the possible failure mechanism by compression of wallettes with historic bricks. Referring to the experimental tests described on masonry wallettes with bricks in scale  $1/3^{\text{rd}}$ , the following historical masonry values can be adopted: brick compression strength,  $f_b=15.4 \text{ N/mm}^2$ , and tensile  $f_{b,t}=1.5 \text{ N/mm}^2$ ; Young’s modulus of mortar  $E_m \approx 5.0 \text{ kN/mm}^2$ , and Poisson’s ratio of mortar  $\nu_m \approx 0.20$ ; masonry compressive strength  $f_w =$

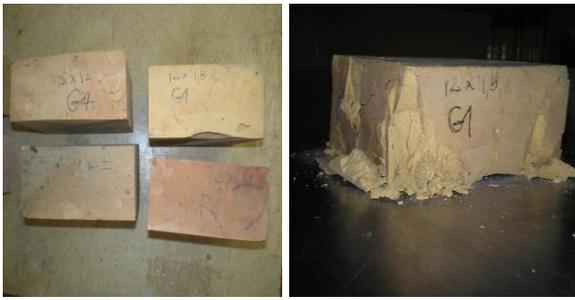
Figure 3 - (a) Specimens of historic bricks subjected to compression tests; (b) view of compression failure.

Compressive and tensile strength of bricks are two fundamental mechanic parameters useful to describe behavior at failure of historic brickwork. Compression was experimentally evaluated on real scale brick samples and on 1/3 scale samples. Eight historic brick samples measuring approximately  $120\text{mm} \times 120\text{mm} \times 50\text{mm}$  (Figs. 3(a), (b)) were subjected to compression to failure in order to determine resistance to compression  $f_b$ . A sample failure can be seen in Fig. 3(b). Experimental results confirm the vast variability of resistance in the case of solid historic bricks: mean experimental resistance is equal to  $f_b = 15.40\text{N/mm}^2$ .

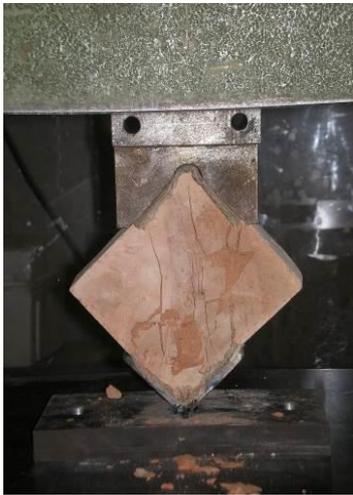
Figure 4. Square historic brick model under diagonal compression at failure.

Tensile strength,  $f_{bt}$ , was experimentally evaluated on samples obtained by real scale historic bricks. The samples shown in Fig. 4, measuring approximately  $115\text{mm} \cdot 115\text{mm} \cdot 50\text{mm}$ , underwent diagonal compression to failure. The diagonal tensile strength of the brick was experimental evaluated using *Brazilian test* on a square brick sample and average value, and determined using the following expression, is equal to  $f_{bt,av} = \frac{2 \cdot P}{\pi \cdot D \cdot t} = 1.51\text{N/mm}^2$ . It can be noted

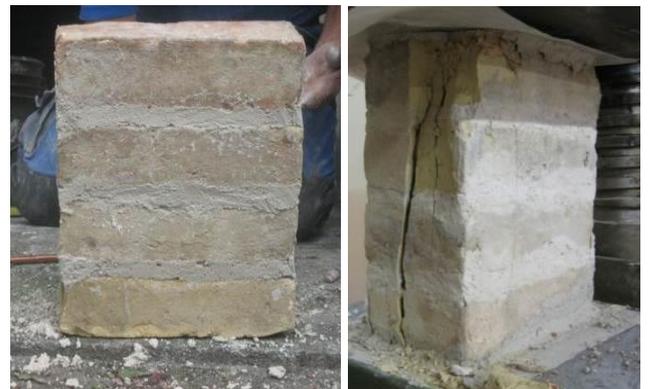
Figure 6. Brickwork wallette with historic brick.

Wallettes built using real scale historic bricks on historic is described below. A typical wallette with historic bricks is shown in Fig. 6 before compression tests and the failure cracking after reaching maximum load. Experimental tests have been developed considering wallettes with different joints thickness 4mm-8mm and 12mm respectively for W1, W2 and W3 samples. From the experimental compression test on wallettes with historic bricks it can be observed that once again failure appears with a development of tensile cracking parallel to the load axis, following the tensile strains orthogonal to the principal compression strains.

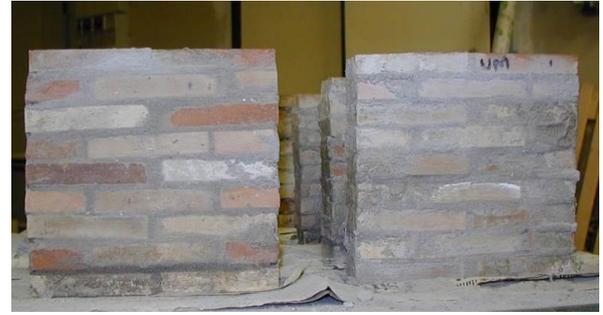
Figure 7. Wallettes with solid bricks in scale.

Compressive tests were carried out on wallettes built with historic bricks (Fig. 7) obtained from sawing full-scale bricks measuring approximately 200mm·200mm·50mm (Capozucca 2017).

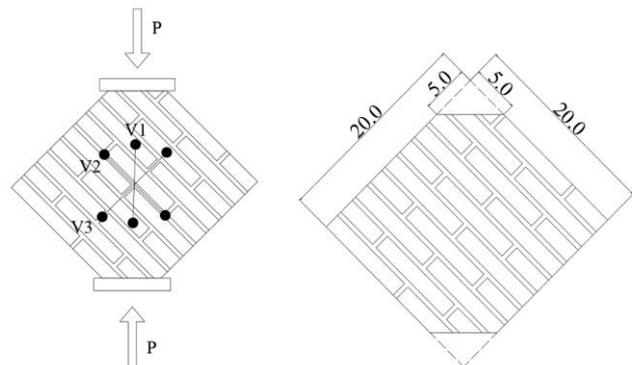
Figure 8. Wallette with solid bricks under diagonal compression test.

Diagonal compressive tests on two specimens of brickwork with bricks in scale 1/3<sup>rd</sup> were carried out to evaluate the tensile capacity of wallettes. Figure 8 contains the dimensions of the specimen and the set-up of the measurement equipment on one side.

Evaluated according to ASTM E 519 standards, the experimental values for the average tangential stresses to failure are  $\tau_u \approx 1.14 \text{ N/mm}^2 \div 1.15 \text{ N/mm}^2$  for the two wallettes. These values do not differ much from resistance  $f_{w,t} \approx 1.0 \text{ N/mm}^2$  obtained considering the test as Brazilian test for theoretical diameter  $D=210 \text{ mm}$  equal to length of one side.

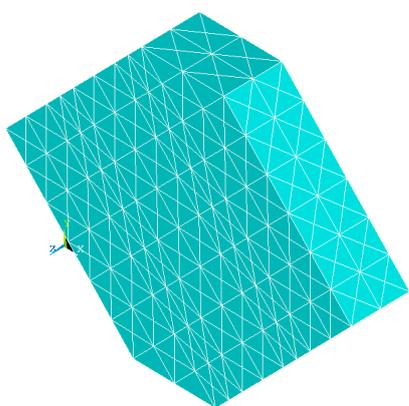
Figure 9. FE triangular mesh of brickwork.

A numerical analysis was conducted by FEM on the specimens subjected to diagonal compression by adopting a linear elastic analysis and using three dimensional modelling by code Ansys. Generally, when modelling masonry elements two approaches are used: either micro or macro-modelling (Gambartotta and Lagomarsino 1997; Lourenço 2002; Milani et al. 2006). Each of the wallettes studied with diagonal load was studied using macro-modelling, assuming masonry both as an isotropic and orthotropic material. Assuming masonry as an orthotropic material appears to be more congruent to the different elastic properties in the two main directions, parallel and perpendicular, to the mortar bed joints.

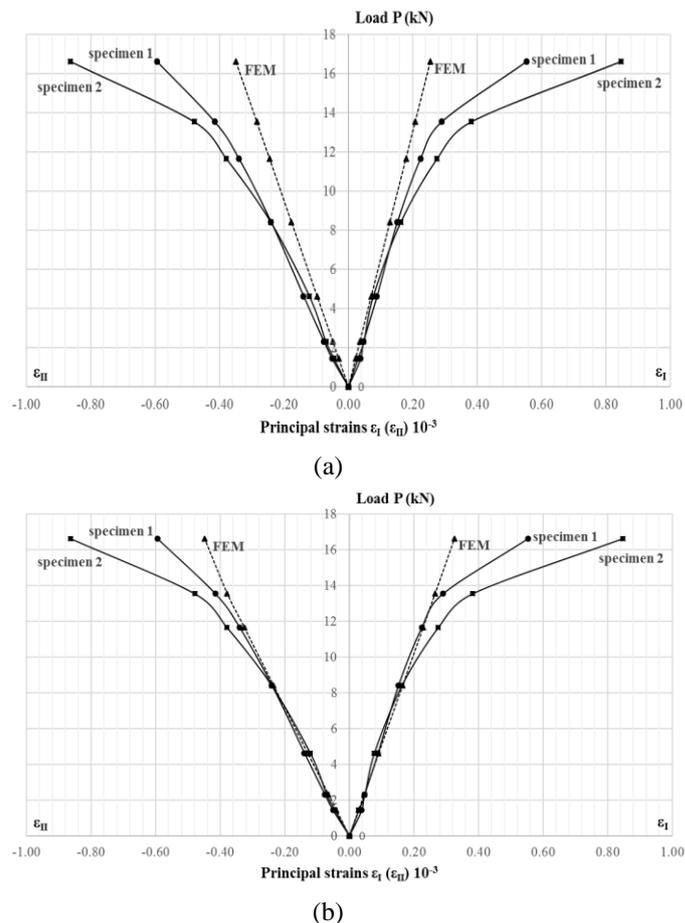
Figure 10. Comparison between theoretical and experimental diagrams load,  $P$ , versus principal strains  $\varepsilon_I$ ,  $\varepsilon_{II}$ : (a) isotropic and (b) orthotropic material.

We can note how, elastic analysis, in the case of orthotropic material, leads to a congruent comparison between experimental and numerical values. Thus, we can underline how in analysis using FEM, masonry material as orthotropic, produces more reliable results.

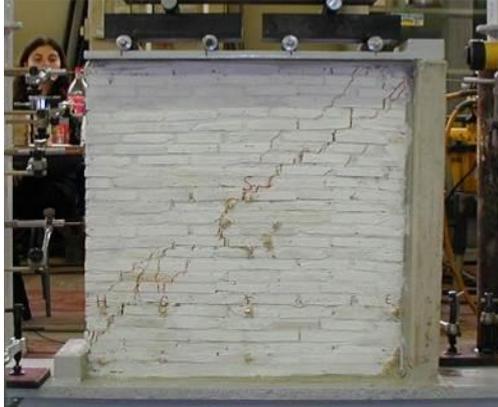
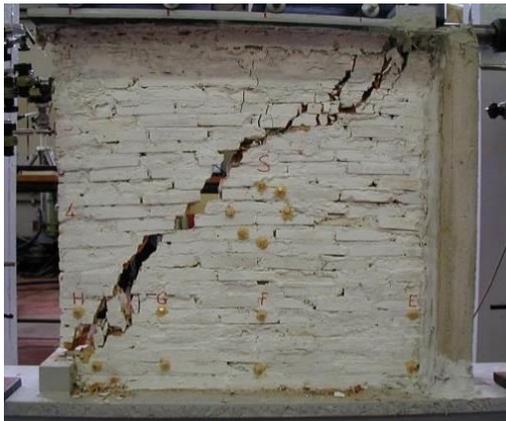
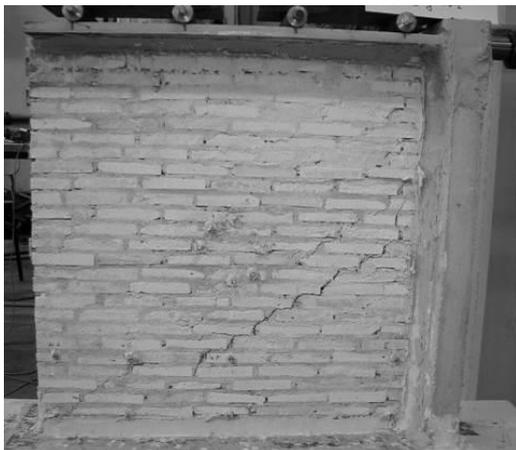
(a) W1s - pre-compression  $0.50 \text{ N/mm}^2$

(b) W2s - pre-compression  $0.75 \text{ N/mm}^2$

(c) W3s - pre-compression  $0.30 \text{ N/mm}^2$

Figure 11. Wall specimens under compression and shear tests: (a) W1s - pre-compression  $0.50 \text{ N/mm}^2$ ; (b) W2s - pre-compression  $0.75 \text{ N/mm}^2$ ; (c) W3s - pre-compression  $0.30 \text{ N/mm}^2$ .

predicted through testing on small scale models (Hendry and Sinha 1971). Walls W1s-W3s were subjected to relatively low values of pre-compression, respectively, equal to  $0.50 \text{ N/mm}^2$  and  $0.30 \text{ N/mm}^2$  and they reach failure with cracks in the mortar joints (Fig. 11).

Wall W2s was subjected to a higher pre-compression value equal to  $0.75 \text{ N/mm}^2$ ; here failure occurred with cracks through the mortar joints and bricks.

Table 4 shows the main values of shear stress at failure. In the case of wall W1s the first crack occurs in the vertical joints; then horizontal cracks also appear along the diagonal of the wall, forming stepped cracks. The two parts of the panel followed to slip but the horizontal force did not increase significantly. It can be noted that when the first crack occurred, behaviour became non-linear to complete failure, achieved at horizontal force  $F=20.8 \text{ kN}$ . As seen in the case shown in Fig. 9, principally, the cracks followed the joints, so it suggests that failure criterion to be adopted is Mohr-Coulomb, a frictional one (Capozucca 2017).

In wall W2s no evident cracks formed before failure. Therefore, there is no ‘plastic’ range and diagonal cracking occurs suddenly when horizontal load achieved  $F \approx 21.4 \text{ kN}$ . Fig. 11 shows how the crack crossed both joints and bricks in this case, hence the material behaved as a homogeneous continuum. This suggests that failure criterion to be adopted is diagonal tensile failure (Capozucca 2017).

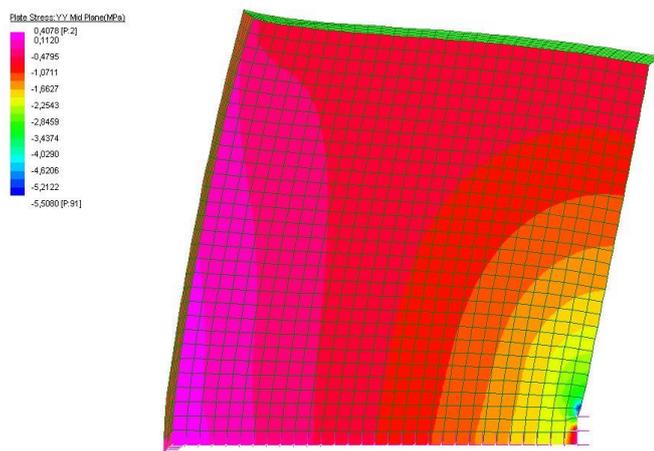
Figure 12. FE shape and vertical compression stress distribution with horizontal force  $F=15.6\text{kN}$  orthotropic material (wall W1s).

The failure mechanism is combined; it is characterized by loss of resistance both for shear with slipping in the mortar joints, and by the bricks' loss of tensile strength in the area with greater compression. At lower pre-compression levels, panel W1s with pre-compression stress

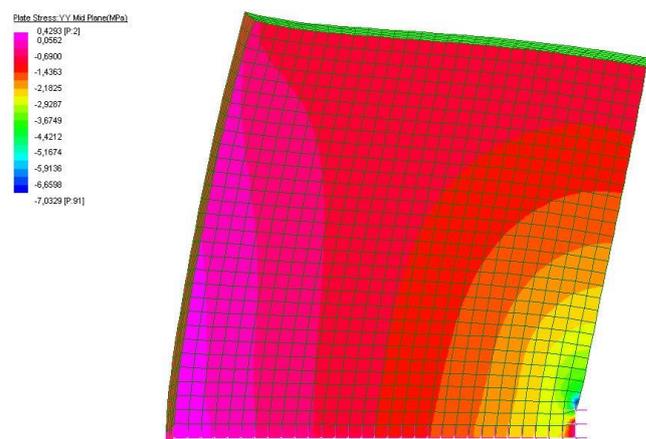
Figure 13 - FE shape and vertical compression stress distribution with with horizontal force  $F=19.0\text{kN}$  - orthotropic material (wall W2s).
