The S. Maria di Collemaggio basilica: from the vulnerability assessment to the first results of SHM

Keywords: Structural Health Monitoring; Architectural Heritage; Dynamic Identification; Seismic Vulnerability Assessment; Masonry Dynamics

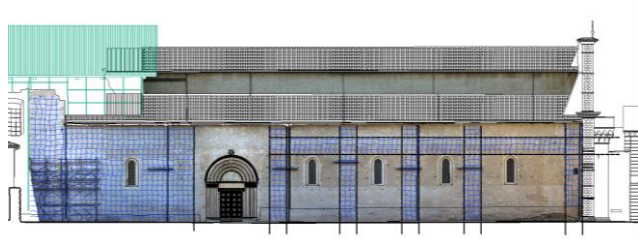
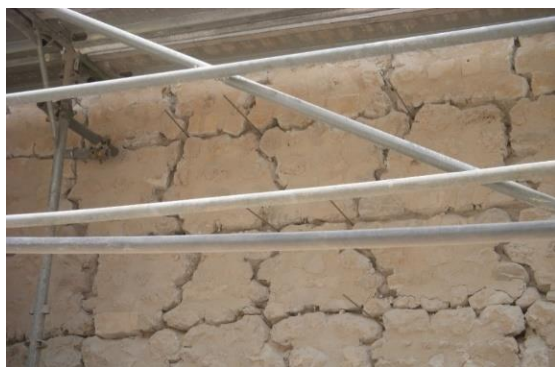
Figure 3: Holy Door wall: areas affected by structural reinforcement similar to the "Reticulatus" system (a); particular (b).

applying repointing mortar and high strength stainless steel wires. The reinforcement system, similar to the "Reticulatus" (Corradi et al. 2016) allows the reinforcement of regular and irregular-shape masonry walls, when the fair-faced aspect must be kept. It consisted in the insertion in the mortar joints, stripped to a depth of 50/70 mm, of a continuous mesh made from high strength steel wires (Fig. 3), whose nodes were anchored to both sides of the wall by means of transverse steel bars. The high strength steel wires, reinforcing both sides of the Holy Door wall, were anchored to the ground by diagonal helical bars inserted in grouted holes, while the ones, applied to the central naves, were anchored over the pillars heads. To prevent the main facade from overturning, the existing brick masonry spur was reinforced by high strength steel strips, steel retaining ties and twisted stainless steel reinforcements were added (Fig.4) . The masonry vaults were strengthened at their extrados by carbon FRP strips (Fig.5).

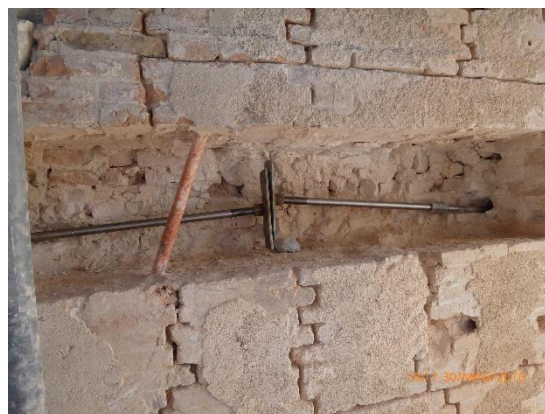
Figure 4: Steel retaining ties to prevent the main facade from overturning.

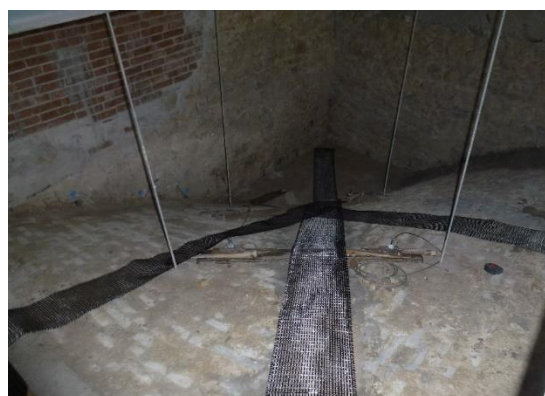
Figure 5: masonry vault strengthened at their extrados by carbon FRP strips.

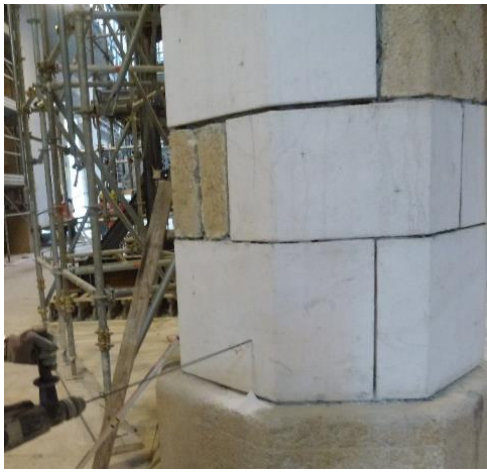
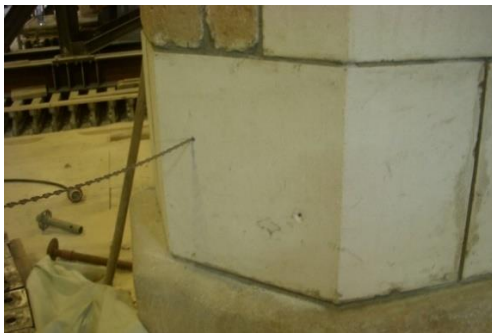
Figure 6: Reinforcement of masonry columns by means of helical steel bars: core hole (a); inserting the bar (b).

The masonry pillars of the nave walls were strengthened and confined by helical stainless steel reinforcing bars (Fig. 6).

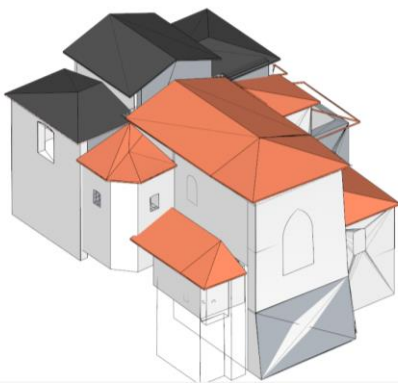
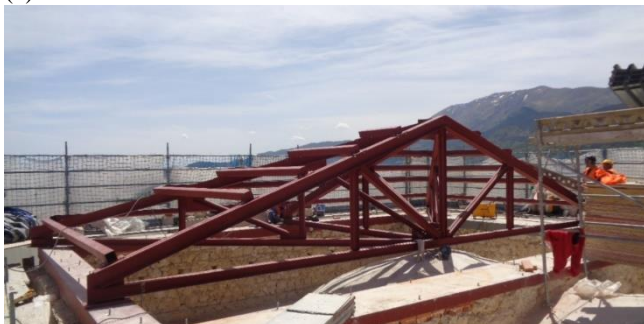
Figure 7: Steel roof structure designed to replace the existing RC structure over the apse, the chapels and sacristies (in orange (a)); Installation of the steel structure (b).

Timber and steel roof structures replaced the previous ones: traditional timber trusses covering the nave walls were topped by Cross-Lam Timber (CLT) panels (Longarini et al. 2018), a steel frame structure replaced the RC roofs over the apse, the chapels and the transept (Fig. 7). The interventions enhanced the box-like behaviour. In order to prevent the out-of-plane mechanism of the apse retaining steel ties were further added.

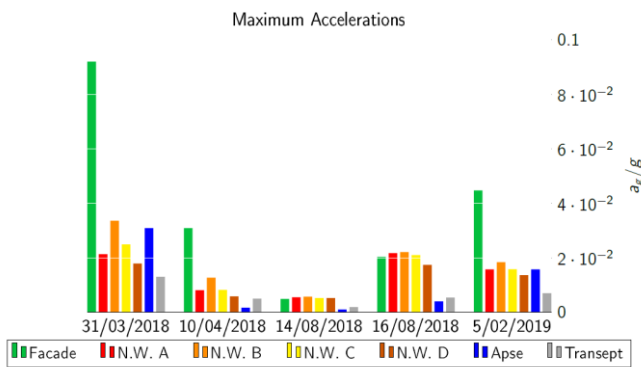
Figure 11: Histogram representation of the maximum accelerations recorded by the monitoring system for each macroelement.

So far, the monitoring system was triggered 5 times by seismic events. In Fig.11 the histogram representation of the maximum accelerations recorded by the monitoring system for each macroelement: the facade, the nave walls (progressively labelled N.W. A-D starting from the Holy Door Wall), the apse and the transept. The facade was surely the macro-block mostly invested by the earthquakes; the nave walls almost

have the same maximum accelerations, while the apse and the transept show the least recorded values. The seismic response of the basilica has been further investigated by means of Input-Output identification techniques by (Aloisio et al. 2019) showing a non-stationary behaviour under earthquake due to possible rocking phenomena (Di Egidio et al. 2019). The facade natural frequency at 4.4Hz, may shift towards 4.2Hz with higher amplitude of the excitation.
