# Retrofitting of existing tunnels with concrete lining: a preliminary experimental investigation

*Keywords: Retrofitting of tunnels; concrete lining; thin layer of high-performance mortar; experimental study.*

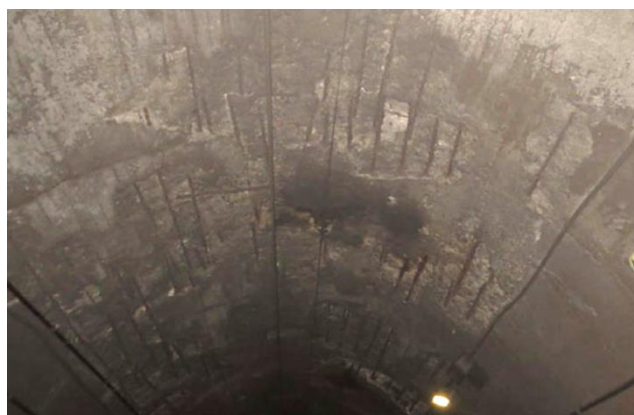
Figure 1. Example of degraded concrete tunnels (repertoire image).

Many concrete tunnels were constructed to serve as important infrastructures as railway, subway, road transportation tunnels or water supply. As shown in Figure 1, concrete tunnels inevitably degrade for different reasons: material aging, aggressive condition and extreme loads etc. This is revealed in the form of concrete cracking, delamination and spalling, water leakage, and steel or reinforcement corrosion (Balaguer et al. 2014, Mashimo and Ishimura 2006, Mckibbins 2009).

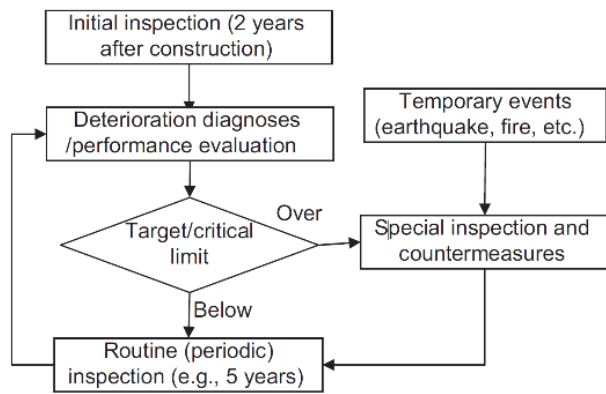
Figure 2. Chart of maintenance steps from JRB 2014.

The maintenance of the tunnels is typically performed going through several steps: periodic inspections, special inspections, performance evaluation and repairs or rehabilitations (see Figure 2 by JRB 2014). Periodic inspections are typically performed to visual level monitoring deterioration conditions of materials as corrosion, cracking and delamination/spalling. Special inspections are carried out when significant deteriorations are observed in the tunnels; in this case important structural rehabilitations are necessary, entailing high costs .

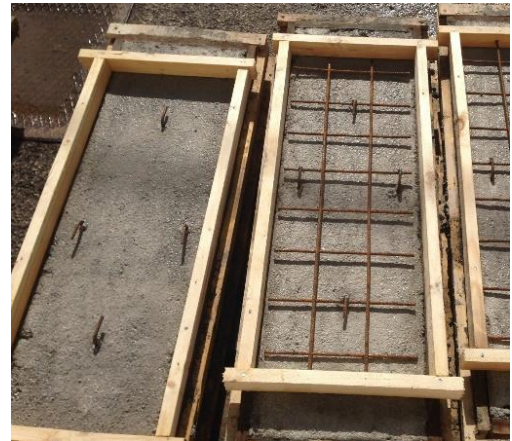
Figure 4. Installation of the electro-welded net and shear connectors.

In order to install the on-side reinforcement, the following operations were carried out. Execution of the holes for the housing of the "L" shear connectors and subsequent removal of dust and loose particles from the inside of the holes by means of compressed air. Then, electro-welded wire mesh was placed by means of spacers. After that, shear connectors were installed with a chemical adhesive. The adhesive was applied by extruding, starting from the bottom, the resin inside the hole up to fill it and inserting "L" shear connectors into the hole by means of a rotary movement to remove the air, until the excess resin came out from the hole itself.

Welded net was fixed to the shear connectors by wire and then the spacers were removed after the chemical adhesive hardened. In Figure 4 are shown the specimens with and without electro-welded mesh.
