Multi-linear models for the rapid assessment of the vulnerability of unreinforced masonry churches involved in the 2016-2017 Central Italy seismic sequence

Alessandra Marotta^a, Domenico Liberatore^a, Luigi Sorrentino^a

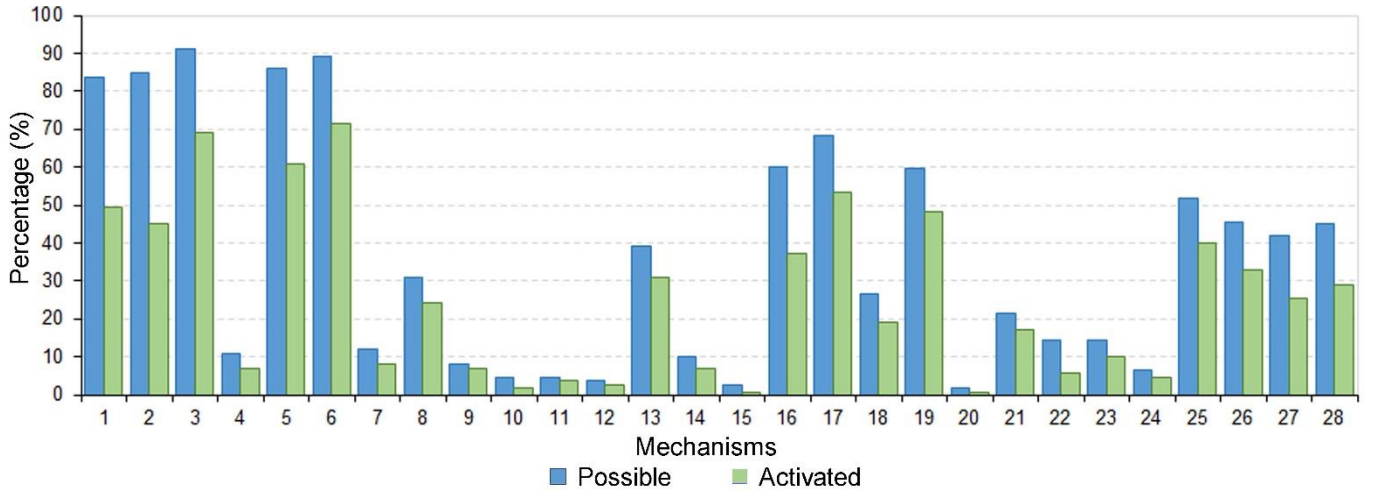
Figure 3. Percentages of possible and activated mechanisms over the sample of 158 churches.

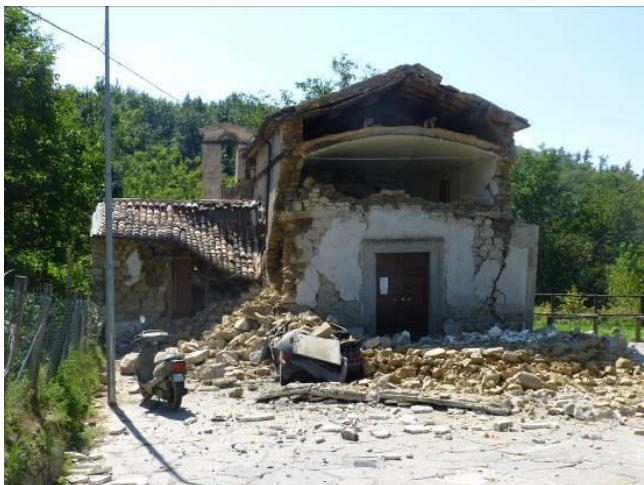
Figure 4. Example of poor quality masonry causing wall disintegration: San Lorenzo Martire (Cossito, Amatrice)

For the twenty-one mechanisms considered, the coefficients defining the selected multiple-linear regressions of Eq. (1) are presented in Table 3. Despite not included in the current Italian form, poor masonry quality was found to be crucial for at least twenty mechanisms. It is also important to highlight that the presence of poor masonry can lead to wall disintegration (examples in Figure 4),

before a rigid-body mechanism can be activated. In the case at hand, this phenomenon was observed in 21% of the activated mechanisms. Therefore, masonry performance is crucial and the investigation of its mortar is recommended (Liberatore et al. 2016). Other very relevant modifiers are connections, between intersecting walls or between walls and horizontal structures, which influence twelve regressions. On the contrary, despite it is widely known that tie rods help to reduce the overturning of the walls (Giresini et al. 2018), they seem to play a negligible role, probably due to the predominance of other modifiers such as connections. It was also found that buttresses only slightly influenced the predicted damage, but their presence was detected only in about 15% of the investigated churches. Large slenderness noticeably influenced the two mechanisms associated with the presence of dome and belfry (#14 and #28). Other parameters, such as large openings (whose combined length exceeds 1/3 of the wall length), heterogeneous materials (assigned in case of reed-mat vaults, Figure 5, for mechanism #8 and when two adjacent structural elements are made of different masonry types), asymmetry conditions (e.g., due to eccentricity of a projection with respect to the underlying masonry, or due to juxtaposition of a new extension) and the presence of vertical-stacked-bond vaults, are relevant for specific mechanisms. Negative values of the coefficients are obtained in two cases, since related to vulnerability modifiers rarely present in the relative mechanisms and will require further investigation.

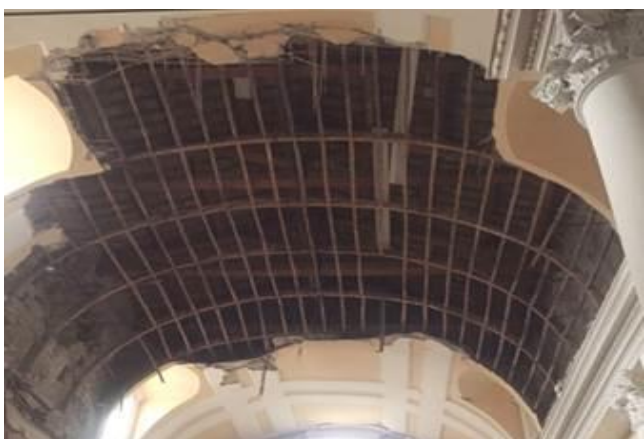
Figure 5. Examples of reed-mat vaults: a) Santa Chiara (Camerino).
