Macroelement modelling of a monitored URM school building accounting for seismic damage accumulation

Francesco Graziotti^a, Marco Solenghi^a, Gabriele Guerrini^a, Andrea Penna^a

^a Department of Civil Engineering and Architecture (DICAr), University of Pavia, via Ferrata 3, 27100 Pavia, Italy

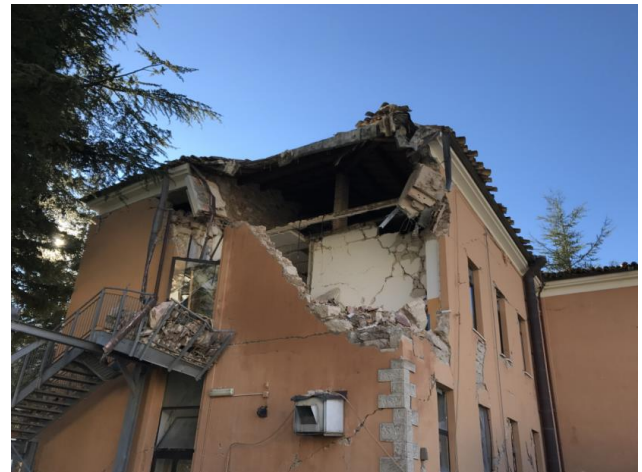
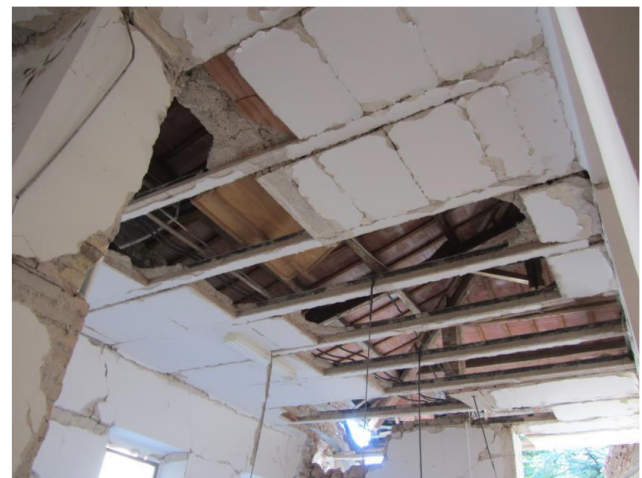
A higher damage concentration was observed in wing “B”, which exhibited a more flexible behaviour compared to wing “A”, causing the out-of-plane collapse of a corner and the collapse of significative parts of the floors (Figure 3). Starting from the signals recorded by the monitoring system, single and double integration of the acceleration time histories related to each accelerometer provided estimation of velocities, displacement and deformations throughout the entire seismic sequence.

Figure 3. Damages in wing “B” after the seismic sequence: out of plane collapse of a corner (top), partial collapse of the attic floors (bottom).

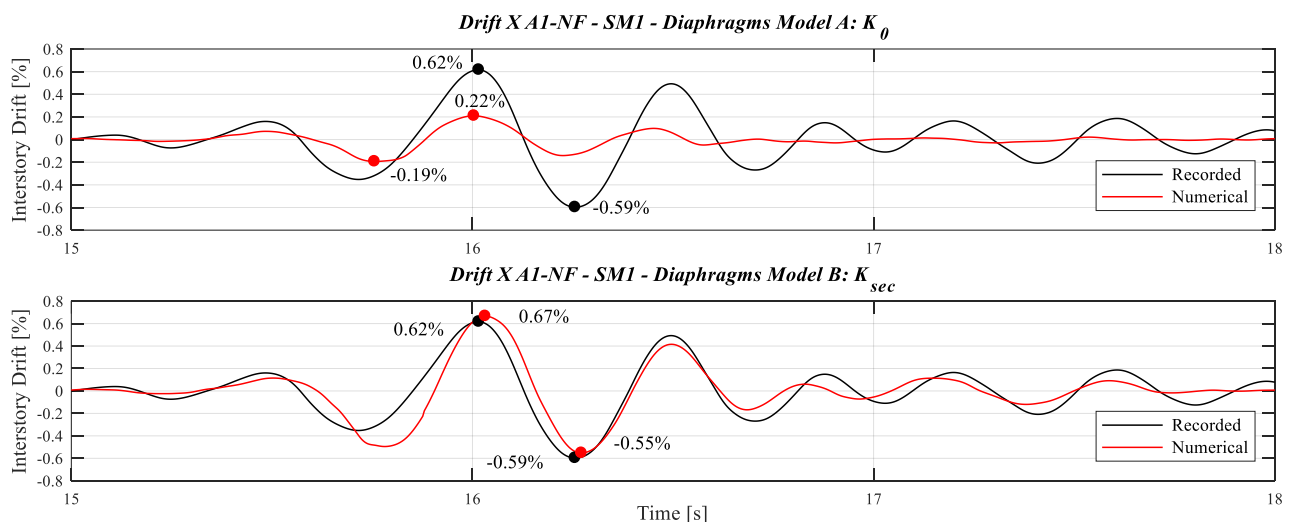
As a first result, Figure 6 compares the first-storey drift-ratio time-histories at the free edge of wing “B”, derived from accelerometer A1 (black) and from the numerical simulation on wall 1 (red) under SM1, adopting different elastic moduli for the diaphragms of wing “B”. For the location of accelerometer A1 see Figure 2, for that of wall 4 see Figure 5. The initial undamaged stiffness (Figure 6, top) led, in this case, to relevant errors on the estimate of the dynamic behaviour of this wing. On the other hand, the secant parameters estimated previously (Figure 6, bottom) allowed a

more accurate prediction of the period and amplitude of the local dynamic response, with an error of about 8% on the maximum amplitude of the signal.

Figure 6. First-storey drift-ratio time-histories obtained from accelerometer A1 (black) and from numerical simulation on wall 1 (red) under SM1: initial undamaged stiffness (top) and secant stiffness (bottom) for wing “B” diaphragms.

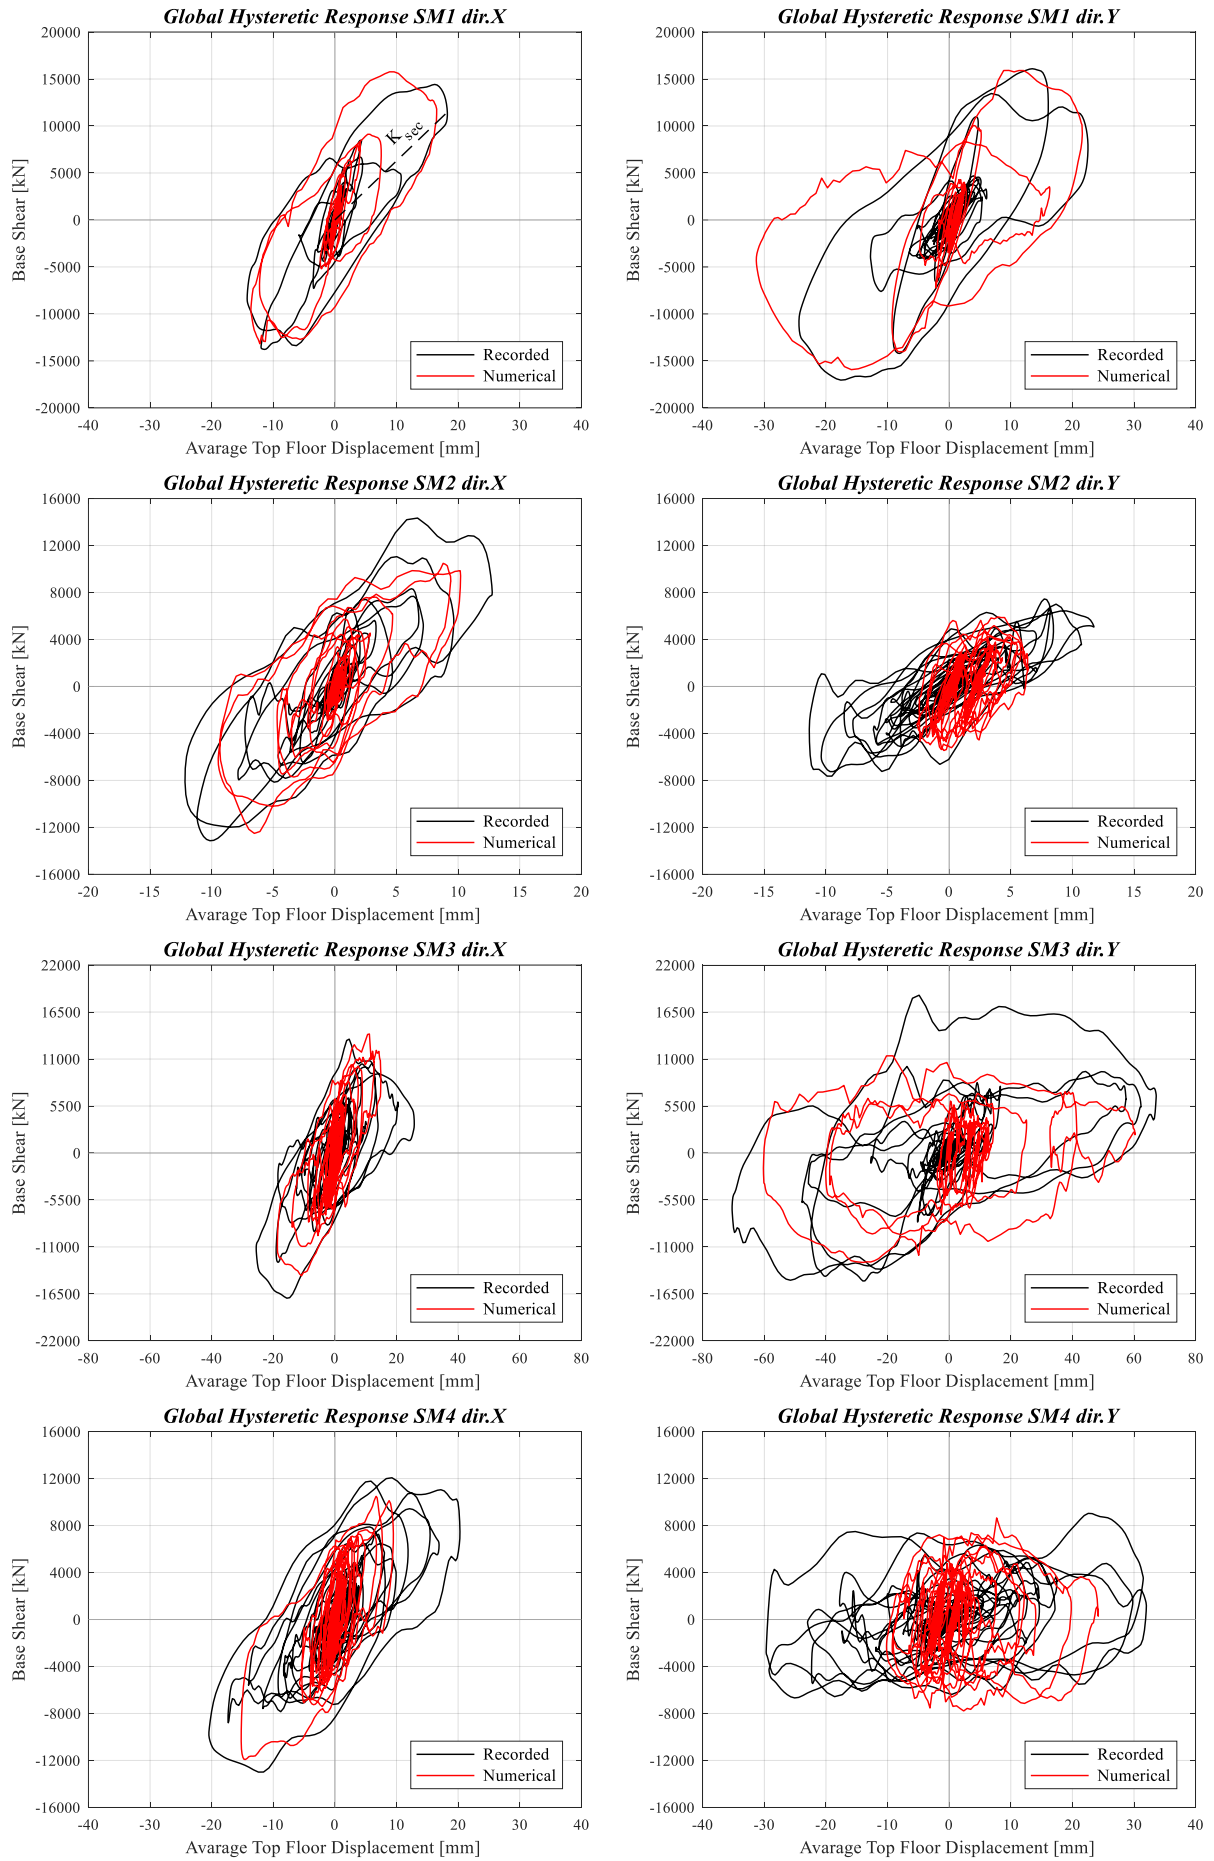
A comparison between recorded (black) and simulated (red) hysteretic curves, obtained plotting the base shear against the top floor displacement, is shown in Figure 7 for the 4 main events of the seismic sequence and for the two principal direction in the horizontal plane, NE-SW (or X) and NW-SE (or Y). During the seismic sequence, the school exhibited a response characterized by a high level of nonlinearity, as testified by the cumulative damage on masonry and floor structural elements.

Figure 7. Global hysteretic response: X direction (left), Y direction (right). From top to bottom: SM1 (August 24, 2016), SM2 and SM3 (October 26, 2016), and SM4 (October 30, 2016).

The numerical model was able to simulate adequately the inelastic behaviour of the building in terms of global stiffness decay, amplitude of hysteretic cycles, maximum base shear (Figure 8), and average top displacement demand (Figure 9). A better accuracy was obtained during the first two events, especially in the X direction, where the structure responded with in-plane wall mechanisms that were well caught by the model. The increased approximation in the following events is probably due to the fact that, during SM3, a significant portion of wall 1 in wing “B” (Figure 5) developed an out-of-plane mechanism that was not explicitly modelled. Furthermore, comparing the accuracy of the model in the two horizontal directions, a slight underestimation of displacement demand in the weak Y direction can be observed.

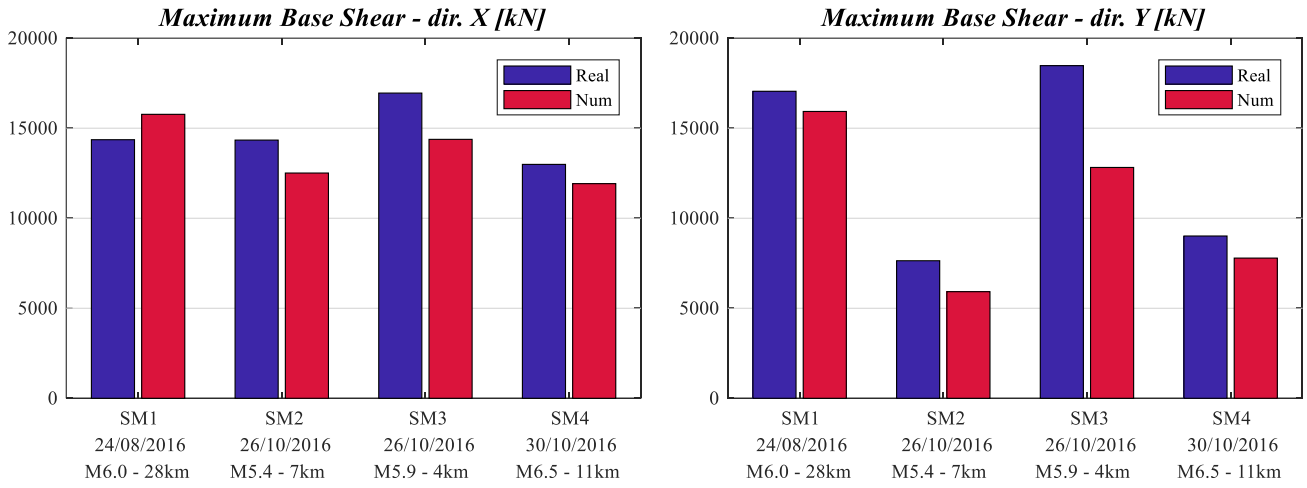
Figure 8. Maximum absolute base shear: actual recordings (blue) and numerical simulation (red).

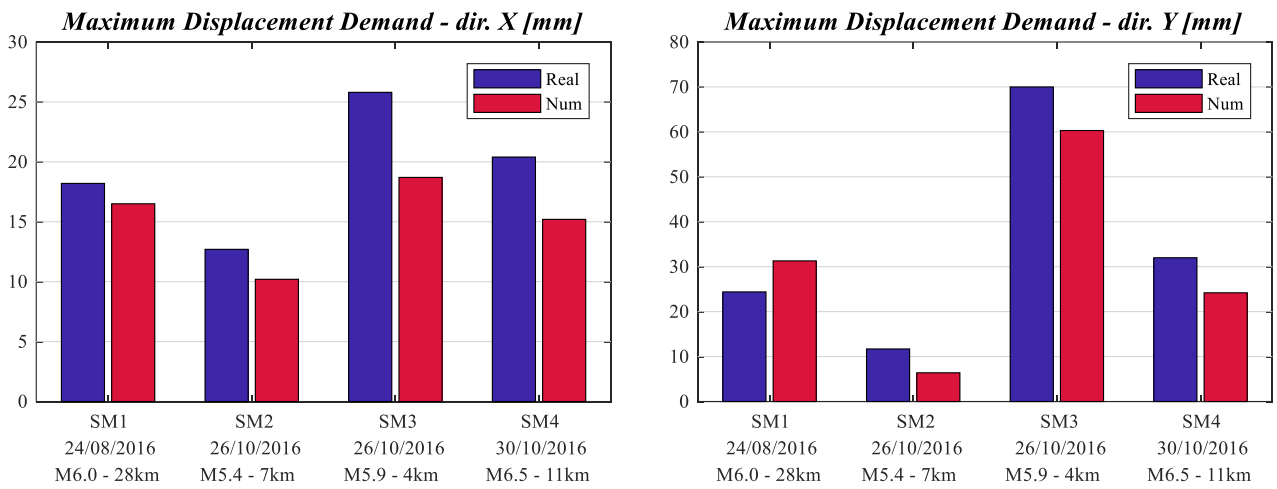
Figure 9. Maximum absolute average top displacement: actual recordings (blue) and numerical simulation (red).

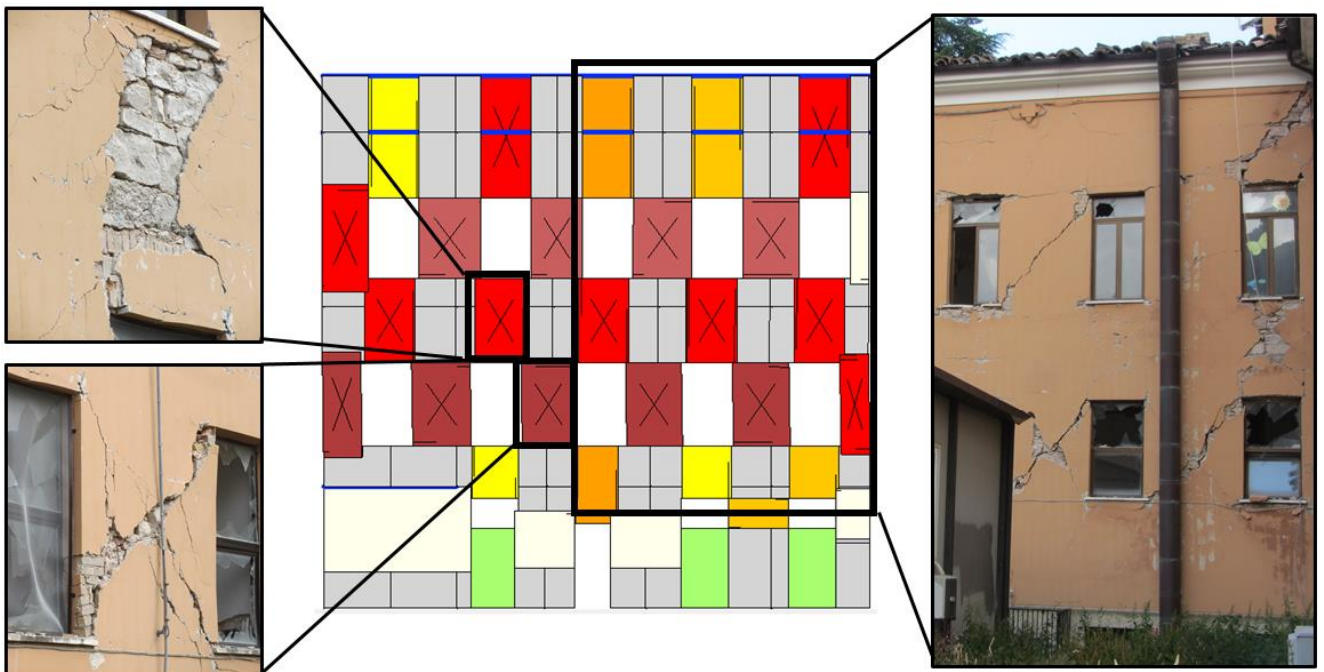
Figure 10. Comparison between the damage obtained from the numerical simulation and the one observed on the building at the end of the seismic sequence, wall 4 of wing "B".

Figure 10 compares the damage level observed at the end of the seismic sequence on wall 4 in wing “B” (Figure 5) with the one obtained by numerical analysis. The adopted discretization was able to simulate with good accuracy the development of shear mechanisms (graphically represented with a cross sign) on piers and spandrels as well as the entire masonry façade behaviour, demonstrating the validity of the equivalent-frame approach in capturing the seismic response of walls with regularly distributed openings which develop in-plane mechanisms.
