Statistical analysis of damages to masonry churches after the 2017 Ischia earthquake

Piera Salzano^a, Francesca Ceroni^a, Claudia Casapulla^b, Andrea Prota^c

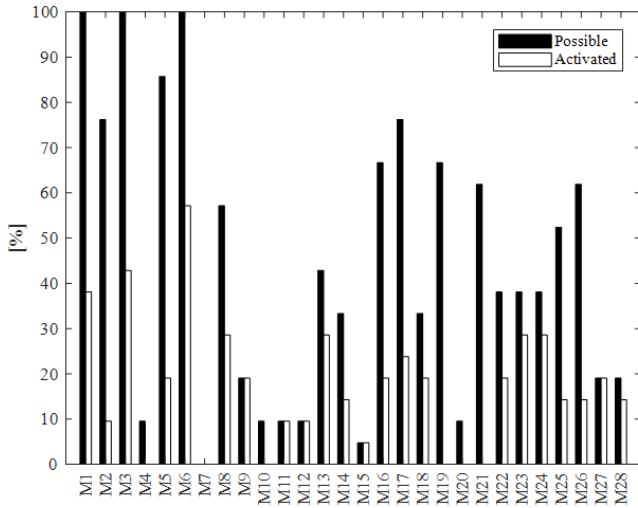
Figure 12. Percentage of potential and activated mechanisms for the 21 one-nave churches.

The correlation between the potential and activated mechanisms in the 21 inspected one-nave churches of Ischia Island is shown in Figure 12. This figure highlights that some mechanisms, such as M3 and M6 (shear mechanism in the façade and shear mechanism in the nave lateral walls, respectively), present the highest percentages of occurrence (45-55%), followed by M1 (overturning of the façade, 40%).

Other out-of-plane mechanisms (such as the overturning of the apses, M16, or chapels, M22) show a lower probability of occurrence (20%). More frequent mechanisms (30% of occurrence) were M8, M23, M24 related to damages to the vaults of the central nave or to chapels walls and vaults.

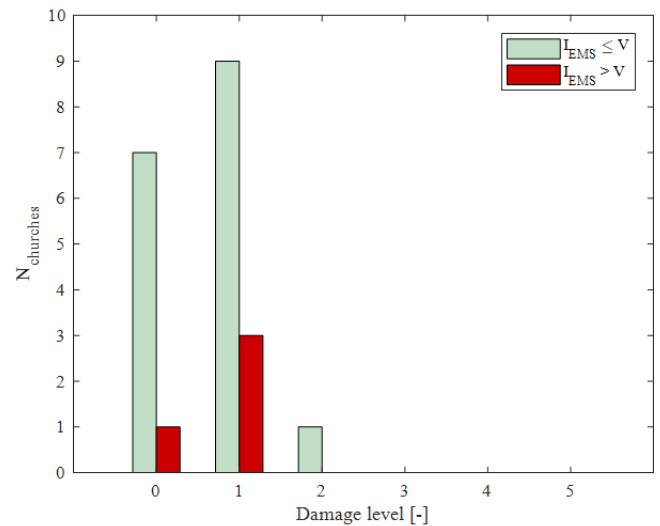
Figure 13. DPMs for the 21 one-nave churches and different values of macro-seismic intensity.

Figure 13 reports the DPMs obtained for two different intervals of macro-seismic intensities ($I_{EMS} \leq V$ and $I_{EMS} > V$). It has to be noted that most of the churches (17 out of 21) belong to the lower macro-seismic intensity interval (see also Section 3.4). Figure 13 also highlights that 41% of churches characterized by low macro-seismic intensity and 25% of churches characterized by high macro-seismic intensity suffered damage level D0. Most of the churches with both low and high macro-seismic intensity (i.e. 53% and 75% respectively) reached damage level D1, while only about the 5% of churches with $I_{EMS} \leq V$ reached a higher level of damage (damage level D2, corresponding to a damage index $i_d=0.25 \div 0.4$).

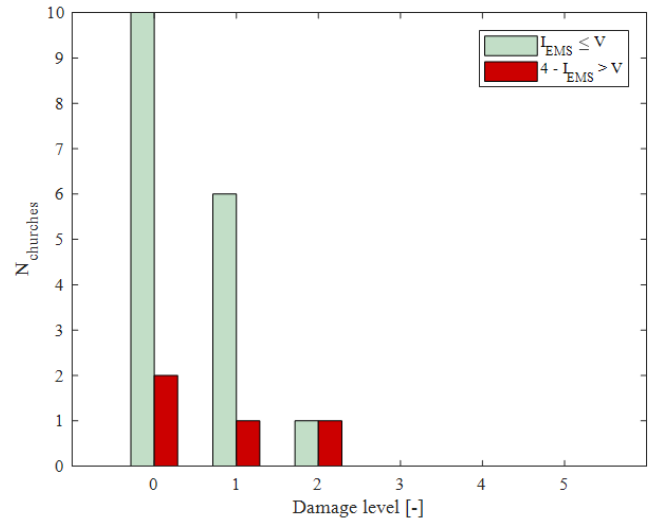
Figure 15. DPMs for M3 - Shear mechanism in the façade, according to two intervals of macro-seismic intensity.

Figure 15 shows that the maximum damage level is D2. Most of the churches reached D0 and D1 levels (94% and 75% for $I_{EMS} \leq V$ and $I_{EMS} > V$, respectively), while a very low percentage of churches reached the D2 level (6% and 25% for $I_{EMS} \leq V$ and $I_{EMS} > V$, respectively).

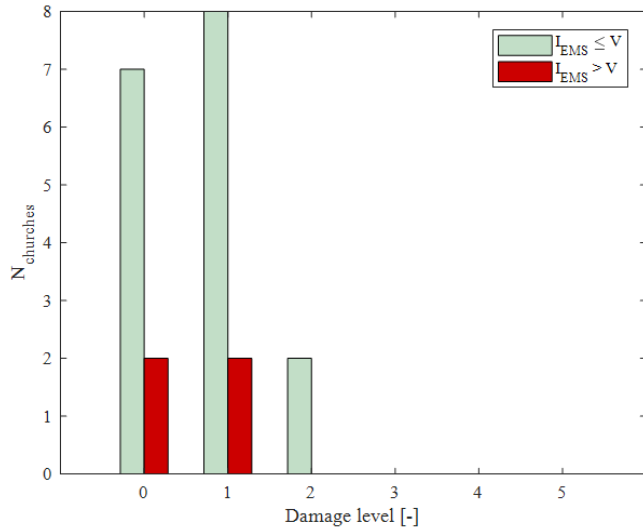
Figure 16. DPMs for M6 - Shear mechanism in the nave lateral walls, according to two intervals of macro-seismic intensity.

Figure 16 shows that for $I_{EMS} > V$ all the four churches reached the D0 and D1 level, while for $I_{EMS} < V$, the 88% of churches reached D0 and D1 and only 12% reached the D2 level.
